A STUDY ON REPAIRING PROCEDURES INVOLVED WITH LEADING EDGE
CRACKS, OFFSETTING, OVERBITE & UNDERBITE OF GLASS FABRIC
REINFORCED COMPOSITE BASED WIND TURBINE BLADES

H.S. Sunil Kumar*, R.B. Anand

Department of Mechanical Engineering, National Institute of Technology, Tiruchirappalli
620015, India

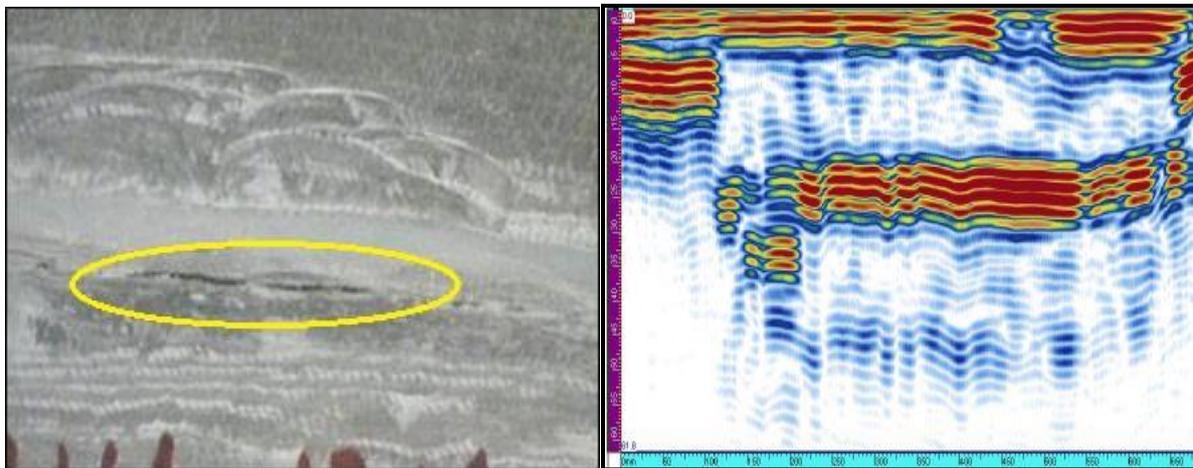
defects like cracks influence the wave propagation resulting in local change. The crack found in the leading edge area is shown in the Figure 2a. This crack is detected using ultrasonic B-scan method and the image recorded is shown in Figure 2b.

Figure 2 (a) Leading edge crack detection in the longitudinal direction and (b) crack detection using ultrasonic B-scan method.

The repair process of leading cracks in the longitudinal direction started with the chamfering the leading edge biaxial layers off. The chamfering ratio in the longitudinal direction adopted was 1:50. The chamfering of the blade area was done in order to accommodate the repair build up with 4 layers of glass fabric. Next the gel coat is removed in order to allow the smooth build up. The crack is then opened using a wedge in the leading edge and is filled with the adhesive in order to glue the crack together. But before that all chamfered surfaces are cleaned using vacuum before laminate application. The cavities appear on the surface after grinding process which is filled with glass rovings as shown in the Figure 3. Glass rovings is thoroughly rolled along the length of the blade, as air should not appear in the laminate. Close lying areas are joined together to one long repair. If the laminate thickness is inadequate to obtain the right profile, extra glass fabric is applied as shown in Figure 4. Leading edge templates are used to check the profile before, during and after the repair. Prior to finishing, re-inspection of repaired blade area is performed using ultrasonic test and finally finish operations are performed on the repaired blade area as shown in Figure 5. Most of the inspection and repair process is done manually as the thickness of the blades varies significantly. On the other hand, Hayashi et al [31] proposed the usage of robot for performing inspection of leading edge part of the blade. The experiments should successful implementation of robot of sufficiently small size using existing facilities to perform inspection and repair.

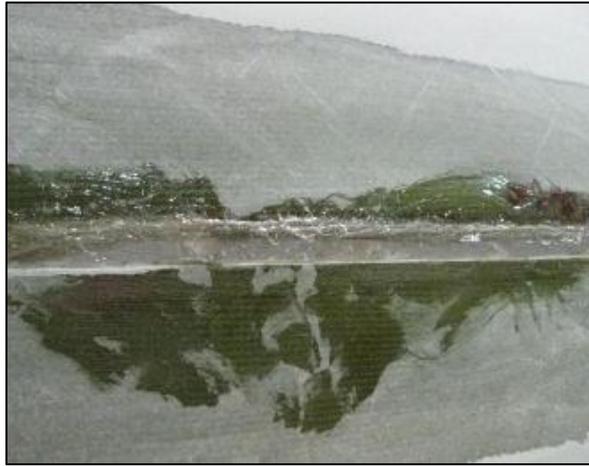
Figure 3 Application of roving in the repaired area

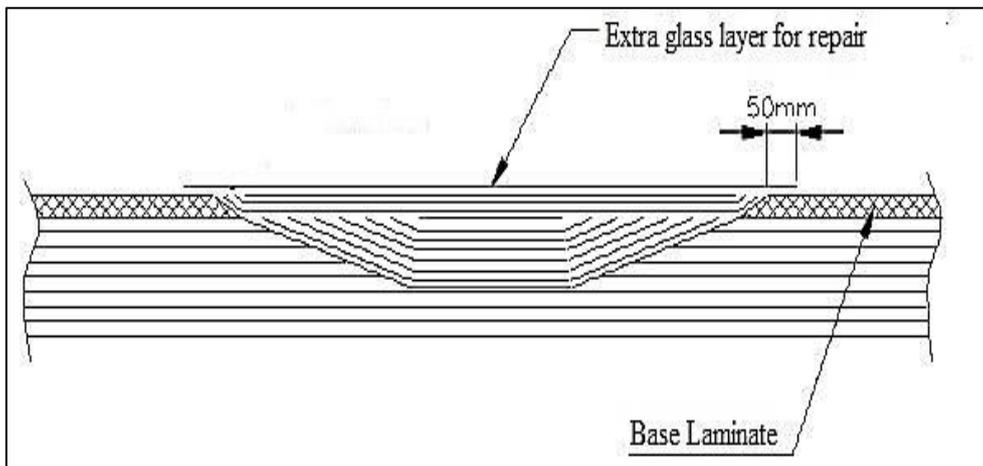
Figure 4 Schematic of leading edge crack repair process

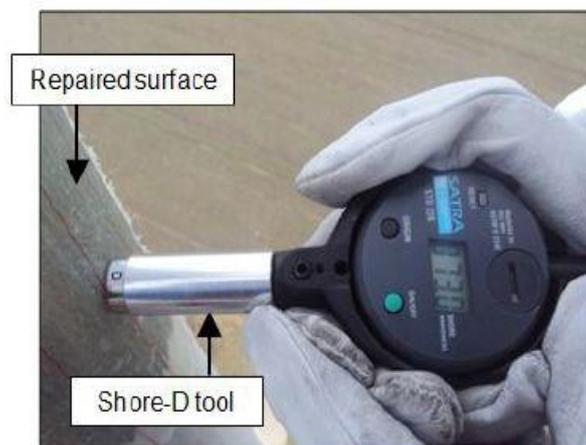
Figure 5 Final inspection of repaired leading edge to check for irregularities

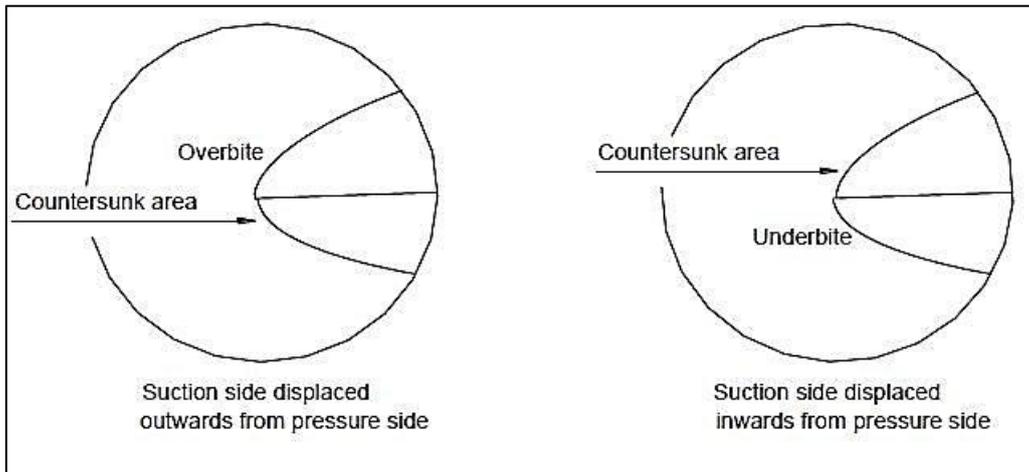
aerodynamic suction side is displaced from the aerodynamic pressure side during closure of the two blade halves. Here Overbite is the aerodynamic suction side of the blade has been displaced outwards in the leading edge relative to the aerodynamic pressure side of the blade. While underbite is the aerodynamic suction side of the blade has been displaced inwards in the leading edge relative to the aerodynamic pressure side of the blade as shown in Figure 6. In the first step we make use of standard leading edge templates to check the level of offsetting which is shown in Figure 7a. The different offsetting defects detected on the same blade are noted down which includes location, size and type of the offsetting on the blade as shown in Figure 7b. Relevant enclosures and photos that thoroughly describe the defect and repair method are noted down. If the offset is reduced in an area by cutting the adhesive joint, then the cutting area and the new level of the remaining offset is noted down.

Figure 6 Overbite and underbite in blade

Once the offsetting on the leading edge i.e. overbite is noted, the next step is to repair process. If the size of the offsetting is within $0 \leq x \leq 1$ mm , then the glass fabric filler is applied. Similarly if the offsetting on the leading edge i.e. underbite with the size of the offsetting is within $0 \leq x \leq 1$ mm, then the glass fabric filler is used. The severity of offsetting detected is analysed and based upon that it is determined to whether the repairing of offsetting can be done in cutting the leading edge adhesive joint. The cutting of offsetting is applicable for the small-sized defects but in order to perform the repair process the cutting of leading edge adhesive joint is generally carried out. The cutting is done in order to ease and improve the offsetting repairs as shown in Figure 8. If the entire aerodynamic suction side of the blade has been displaced forward then the cutting will not be beneficial if the adhesive flange is laminated on the pressure side. On the other hand the cutting will be helpful if the adhesive flange is laminated on the suction side blade shell, then the adhesive might have been squeezed out and the leading edge of the suction side blade shell might have been draw from the mould surface. Similarly if the entire aerodynamic suction side of the blade has been

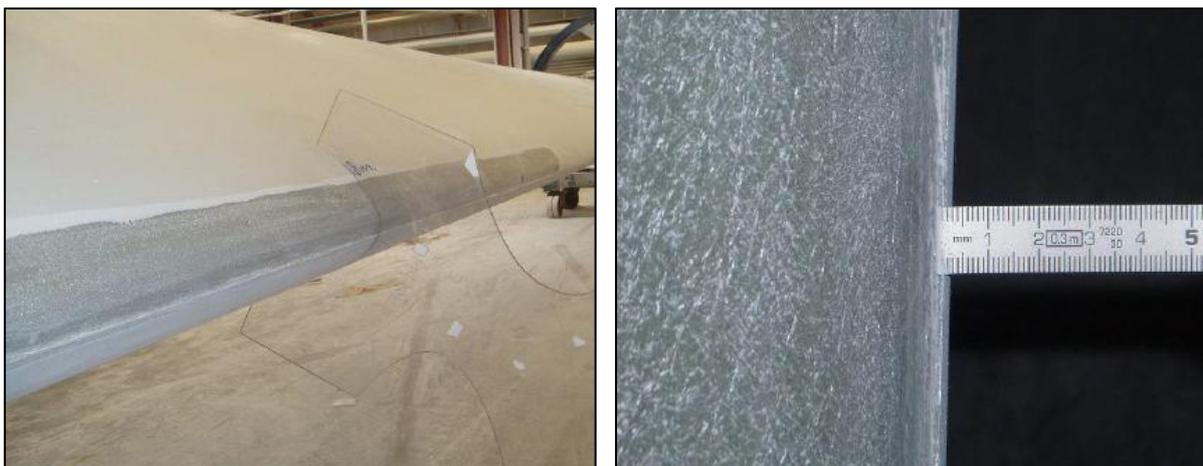
Figure 7 (a) Leading edge template to check the level of offset and (b) recording the size of offset.

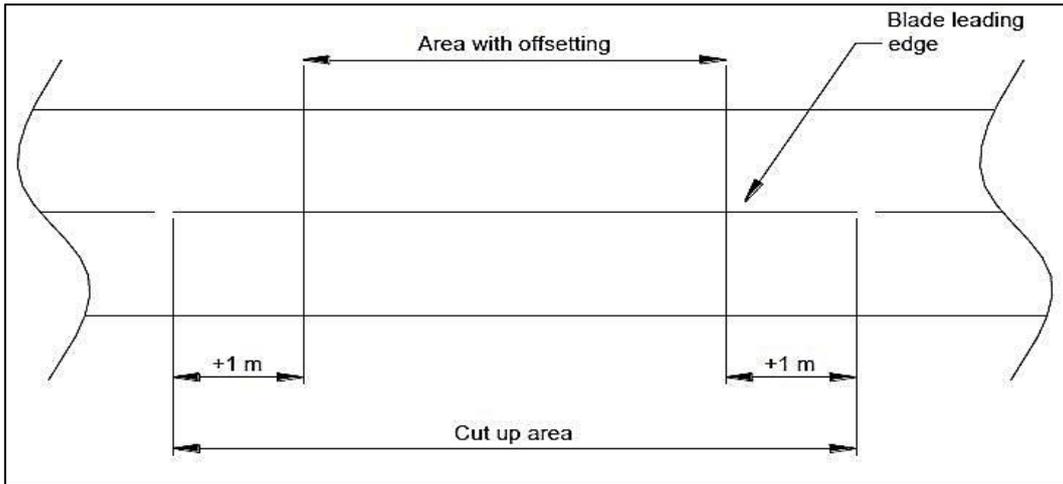
Figure 8 Illustration of cutting of leading edge adhesive joint

So in cutting process, the leading edge area to be cut up is marked such that extension of approximately 1 m to each side. This is done in order to prevent the surrounding laminate from being twisted. The adhesive joint and flange in the marked leading edge area is subjected to cutting such that the blade shell offsetting is reduced considerably. The next step is laminate matting in the area without adhesive flange and build-up of a new internal adhesive flange. Here the same H-glass type fabric and laminate build-up as that of respective blade moulding is used. Glass fabric is thoroughly rolled between each layer and the laminate is allowed to cure until the polyester has peaked and temperature is decreased to max 10°C above the room temperature. After doing this a new leading edge measurement is performed using leading edge templates to check the leading edge profile of the blade. If air bubbles or defects of small size appear around in the repaired area, then cleaning is performed and re-filling of glass fabric filler is carried out.

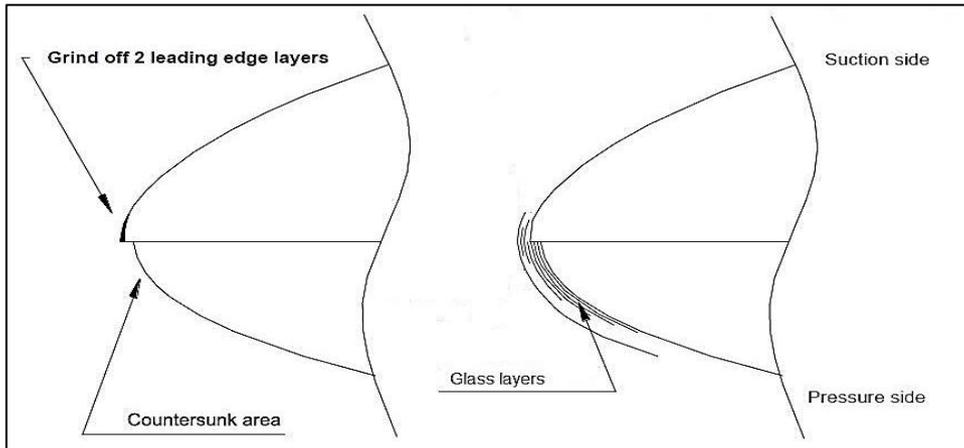
Figure 9 Grinding and application of glass filler in of case overbite repair.

both overbite and underbite situations if the offset is 1 - 3 mm then using leading edge templates the extent of the countersunk area to be repaired is determined. This starts with the grinding of gelcoat in the countersunk area to be laminated as shown in Figure 9. The width and length of the layers to be applied are determined using the leading edge templates. Take into account that the large-sized layer (largest width and length) is applied first. If the extent of the repair in the longitudinal blade direction necessitates the application of additional glass lengths then apply the same glass fabric layers edge to edge in the longitudinal blade direction as shown in Figure 9 and 10. Again glass fabric is thoroughly rolled between each layer in avoid to avoid air entrapment and the laminate is allowed to cure until the polyester has peaked and temperature is decreased to max 10°C. Prior to finish re-inspection of repaired blade area is performed and the finishing operations on the repaired blade area are done. Re-inspection of repaired blade area is carried out again by ultrasonic inspection (B-scan method) method to ensure no defect is present. These mentioned procedures will ensure no defects are present after repair process and blade can be used for operation. In this regard, Marsh [32] briefed above spot repair of impact pit in leading edge using translucent resin to avoid future possibility of moisture absorption into the laminate.

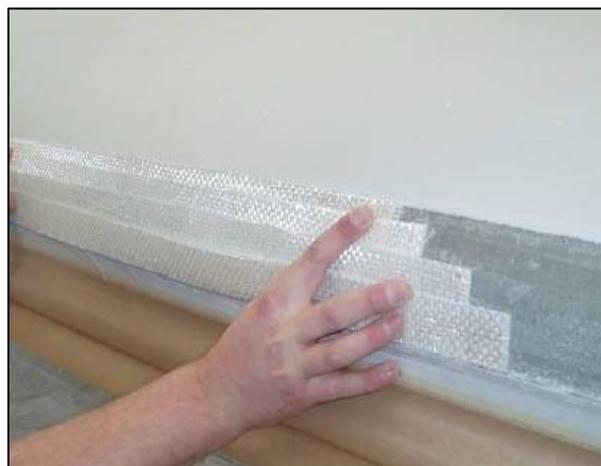
Figure 10 Application of glass filler in case of overbite repair that is leading edge offset
