# 1 Visual Corrosion Inspection, Evaluation, and Repair Procedure for Ship 2 Tanks Navigating the Mediterranean Sea

3 Juan José Galán-Díaz\*, Nuria Varela-Fernández

4 Department of Naval and Industrial Engineering, ETSI Caminos, Canales y Puertos, University of  
5 A Coruña, A Coruña, Spain

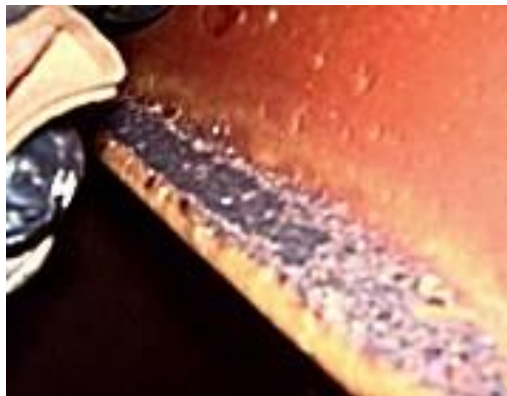
200 The sanitary tank, crucial for the hygiene and proper functioning of the vessel,  
201 presents a significant challenge due to its location and purpose. Corrosion, assessed at 10% of  
202 the total surface during the inspection, may be influenced by the specific environmental  
203 conditions to which this tank is exposed. Given its position and purpose, humidity and  
204 temperature can play a significant role in the corrosive process.

210 Table 3 provides a detailed summary of the corrosion status of the sanitary tank,  
211 highlighting the presence of corrosion (3S), mechanical damage (1L), blisters on 10% of the  
212 surface, and white repainting on 10%, which did not adhere correctly to the original layer,  
213 potentially causing additional damage. Furthermore, the table shows that 80% of the original  
214 coating remains in good condition, but repair is required on 20% of the total surface.

225 Figure 3 depicts the detachments and oxidations observed in the area of reinforcements.

Figure 3 Detachments and oxidation in the area of reinforcement in the sanitary tank.

205 With the aim of addressing these challenges, a high-pressure and high-temperature  
206 water washing strategy was implemented, ranging from 150 to 180 bars and between 70 and  
207 90 °C, in accordance with ISO 8501-3: 2008 [26]. This approach not only removes grease,  
208 blisters, and inadequate repainting but also effectively prepares the tank's surface to receive  
209 the protective coating.

215 The application of an initial layer of gray coating with a thickness of 150 µm was  
216 strategically chosen to address specific damaged areas identified during the inspection. This

219 The choice of the red coating is not solely for aesthetic purposes but is based on its  
220 preventive capabilities. By covering 40% of the total surface, 10% more than affected by  
221 corrosion, this layer aims to prevent future damage and contribute to the long-term integrity  
222 of the sanitary tank. This strategic approach not only addresses the damaged areas but also  
223 establishes a protective barrier to ensure optimal performance of the tank in the demanding  
224 maritime environment.

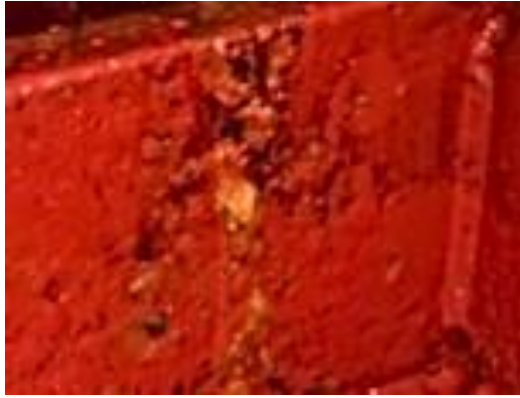
227 This tank is situated at the bow of the ship, in the central section. It exhibits localized  
228 corrosion affecting approximately 15% of the surface, primarily concentrated in the  
229 reinforcement areas and their lower sections. The prolonged presence of liquids in these  
230 regions, coupled with the tendency for the accumulation of dirt, contributes to the onset of  
231 corrosion. Moreover, the reinforcement areas pose challenges for effective coating  
232 application, significantly increasing the likelihood of corrosion. Figure 4 visually illustrates the  
233 corrosion observed in the reinforcement area.

237 The total area of this tank is 580 m<sup>2</sup>. Initially, the surface damage, accounting for 20%  
238 of the tank's total surface, was treated with a 150 µm thick layer of grey epoxy coating. This  
239 stage required a total of 45 L of paint, resulting in a paint yield of 2.6 m<sup>2</sup>L<sup>-1</sup>. In the second layer,  
240 an additional 10% of the tank's surface was covered, which corresponds to 30% of the total  
241 surface, equivalent to 174 m<sup>2</sup>. For this layer, red paint was used. The total volume of coating  
242 applied in this stage was 56 L, resulting in a yield of approximately 3 m<sup>2</sup>L<sup>-1</sup>.

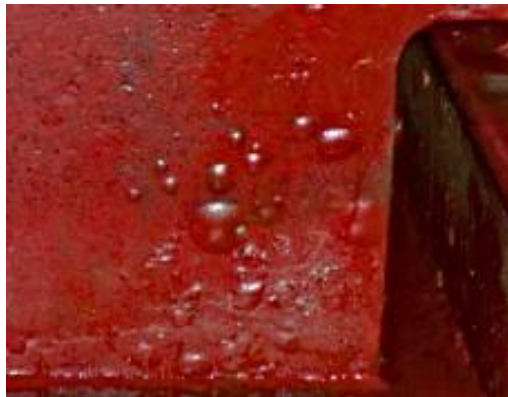
244 This tank is located at the bottom of the ship, specifically in the double bottom area on  
245 the port side. Corrosion is present on approximately 5% of the tank's surface, primarily  
246 affecting the lower sections of the bulkheads and the ceilings. Blisters are visible on  
247 approximately 35% of the tank surface, with an adjacent area exhibiting poor adhesion. In  
248 total, the damage amounts to approximately 40% of the tank's surface. Mechanical damage is  
249 minimal, accounting for less than 2% and confined to a localized area. Figure 5 illustrates the  
250 scattered blisters found throughout the tank.

Figure 5 scattered blisters in double bottom tank 1 PT

251 Before coating, the surface was washed with pressurized water between 150 and 180  
252 bars and a temperature between 70 and 90 °C. This procedure removes exfoliations, salts,  
253 grease, and repainted areas. The first layer of grey coating was applied over the damaged 540  
254 m<sup>2</sup> of the tank, and the second layer, red, covered an additional 54 m<sup>2</sup>. The thickness of each  
255 layer was 150 µm, and the total consumption of paint amounted to 172 L.

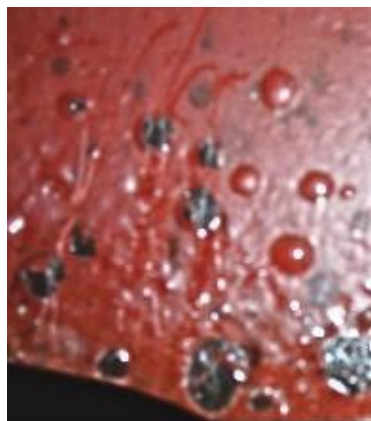
Figure 6: Adhesion issue in double bottom central tank 1

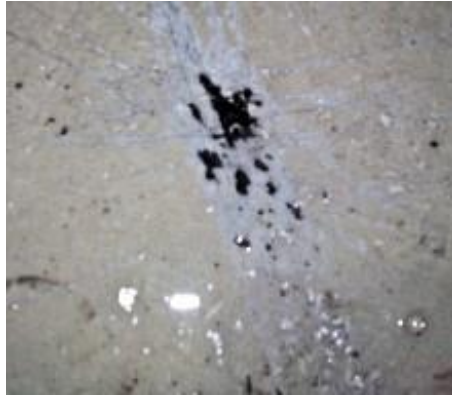
316 This tank is located on the port side of the ship. Corrosion was observed in a localized  
317 manner, representing 5% of the tank's surface, as indicated in the results shown in table 6. The  
318 corrosion can be attributed to mechanical damage and improper repainting, where the original  
319 paint scheme was not followed.

320 There were cracks present on 5% of the tank surface, along with peeling and blisters  
321 scattered across 30% of the surface. Taking into account the dispersed nature of the damage, a  
322 total of 70% of the surface requires repair. The repair process followed the cleanliness  
323 guidelines outlined in ISO 8501-3:2008 for achieving a St3 cleanliness degree.

329 It is worth noting that the preparation process for this tank was more extensive  
330 compared to the previous ones. This is attributed to the fact that this tank is designated for  
331 storing clean water for the crew's consumption. Figure 9 provides a visual representation of  
332 the internal condition of the fresh water port tank 13.

324 To address the damage, a high-pressure and high-temperature wash with fresh water  
325 (between 150 and 180 bar and between 70 and 90°C) was conducted. This wash aimed to  
326 remove blisters, incompatible repainting, and grease from all possible areas. Furthermore,  
327 areas exhibiting exfoliation, oxidation, and detachment were meticulously treated by grinding  
328 and brushing. Additionally, a thorough abrasive blast cleaning was performed.

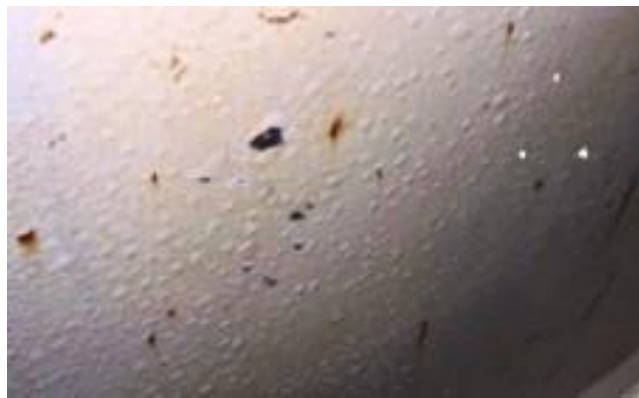
334 This tank is situated on the starboard side of the ship. The corrosion observed in the  
335 tank affected approximately 2% of its surface. The corrosion was primarily a result of  
336 mechanical damage and improper repainting that did not adhere to the original paint scheme.

337 Blisters were found on 50% of the tank's surface, leading to a lack of adherence  
338 between the paint system and the steel, as well as between the paint layers. Considering the  
339 widespread nature of the damage, a total area of 70% requires repair. Figure 10 provides a  
340 visual representation of the corrosion spread within the tank.

Figure 10. Inside part of the fresh water tank 13 SD

341 The repair of this tank was identical to the previous one, since both tanks have the same  
342 mission on the ship.

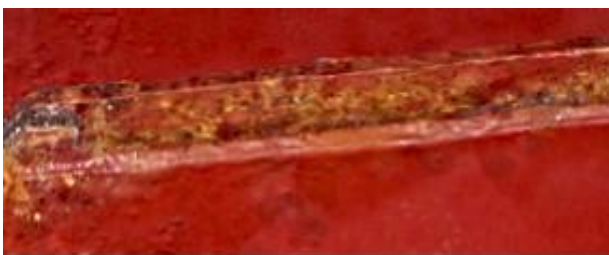
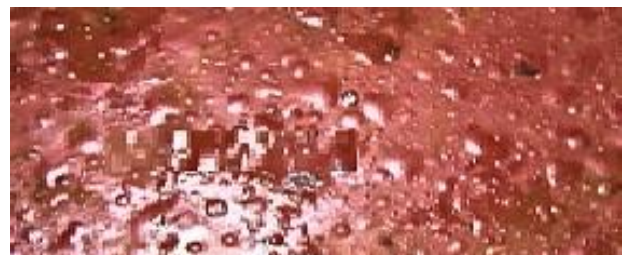
344 This tank is located on the port side. Corrosion was present in 5% of the tank surface  
345 and it was mainly due to mechanical damage. Scattered blisters were found in most of the  
346 tank, the percentage of the floor surface covered by them was 90%, which caused a lack of  
347 adhesion of the previous paint system on the tank floor. Total tank surface damage repaired  
348 was 25%. The above data is shown in a more schematic way in table 7

349 An SA 2<sup>1/2</sup> cleanliness grade is also applied to this tank prior to coating. The blisters were  
350 scattered throughout the floor, covering approximately 90% of the surface. Figure 11.a shows  
351 the mechanical damage and oxidation on ceilings and bulkheads. The blisters were scattered  
352 throughout the floor, covering approximately 90% of the surface (11.b).
