Seismic retrofit of a typical reinforced concrete bridge bent in Iran

Abstract. This paper presents the results of an experimental study which was carried out to identify the vulnerabilities of existing multicolumn bridge bents constructed in Iran and to develop an appropriate retrofit measure to alleviate such vulnerabilities. In this study a three column reinforced concrete bridge bent, which was designed for gravity load with inadequate seismic detailing, is considered. Two identical specimens scaled to 30% of prototype dimensions were tested under in-plane cyclic loading condition. One of the specimens simulated the as-built condition while the other specimen was retrofitted by external prestressing along the cap beam as well as transverse prestressing of an exterior joint. The test results on the as-built specimen indicate that joint shear distress and bond failure of longitudinal column reinforcement within the joints are the predominant failure modes. Such failure modes adversely affected the behavior and energy absorbing capacity of the as-built specimen. Seismic behavior and energy absorbing capacity of the retrofitted specimen improved significantly. The improved behavio

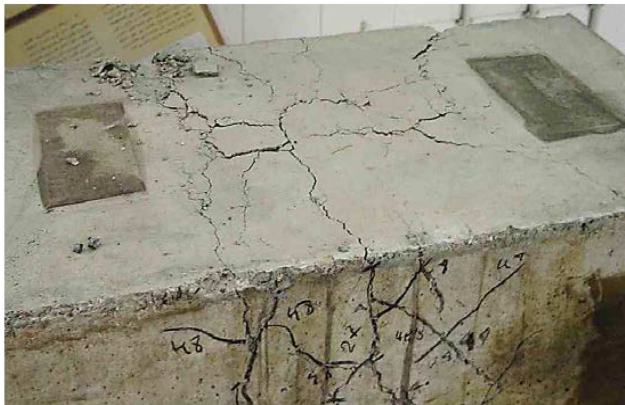
Figure 6. Concrete cracking on top of cap beam - exterior joint.

on top of cap beam, as shown in Figure 6, and visible opening of the cold joint, at the column/cap beam interface, clearly indicated bond failure the column longitudinal reinforcements. Such failure was observed in both exterior and interior joints at displacement ductility factor of 2 and 3, respectively. This failure was accompanied by severe cracking and subsequent concrete spalling in the joint region.

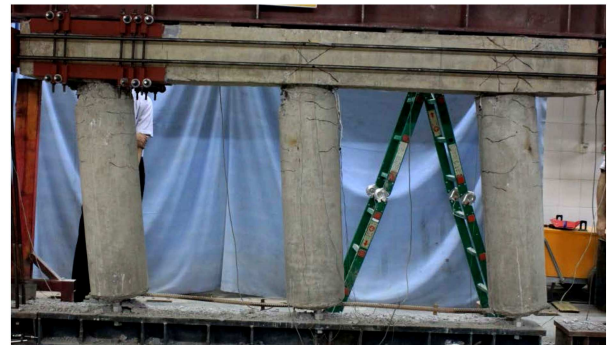
Figure 8. Pictures of retrofitted specimen after the test.

other exterior column was due to slippage of column longitudinal reinforcement which also occurred at this ductility level. Due to such failures, the lateral load resisting capacity of the bent diminished significantly at ductility levels of 5 and 6. Figure 8 shows pictures of the retrofitted specimen at the end of the test. These pictures indicate flexural failure of the interior and the left exterior columns. As shown in these pictures, the left exterior joint which was prestressed in both longitudinal and transverse directions remained totally intact with no cracking while the interior joint experienced minor shear cracking. Due to bond failure of column longitudinal reinforcement, within the right exterior joint, the respected column did not experience significant inelastic action and the damage was limited to moderate flexural cracking near the cap beam.

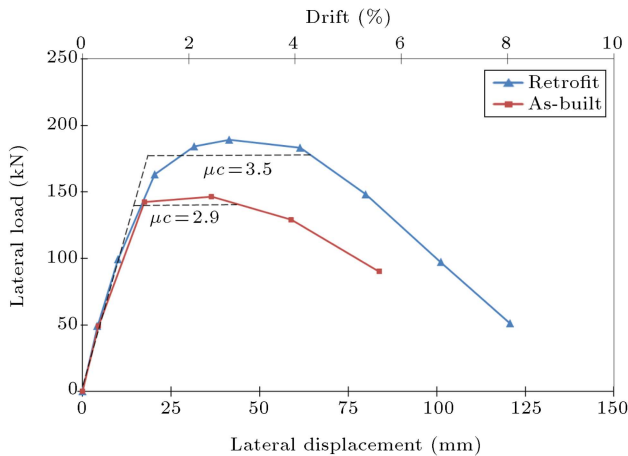
Figure 9. Load-displacement backbone curves.

Figure 9 shows the load-displacement backbone curves of the as-built and the retrofitted specimens. The backbone curves are drawn in accordance with FEMA-356 [12] recommendation through the intersection of the first cycle for the i th deformation step and second cycle at the $(i - 1)$ th deformation step. This type of backbone curves includes the in-cycle strength degradation of the specimens. The ideal backbone curves are also shown with dashed lines assuming that the ultimate displacement occurs at a point where the strength is degraded by five percent. Figure 9 indicates that both strength and ductility are improved as a result of retrofitting. The strength is improved by 28 percent and the ductility is improved by 21 percent.
