Research Note

# Application of petrographic image analysis for the assessment of chemical attack in the concrete segments of a tunnel

**Abstract.** The current study discusses the petrographic image analysis performed on core specimens that are extracted from a tunnel in the south west of Iran. During tunnel excavation, damages were observed in the inner sections of concrete segments. Due to field observations of damaged segments, environmental parameters, and tunnel location, several damage scenarios were proposed. In order to assess damage mechanisms, 69 cores were extracted and a number of standard tests were carried out. Since chemical attacks alter microscopic properties of materials, petrographic image analysis was performed on five specimens to evaluate possible microscopic changes in concrete composition. The results show that petrographic image analysis is an efficient method to provide a profound insight into the effects of chemical attacks on concrete members.

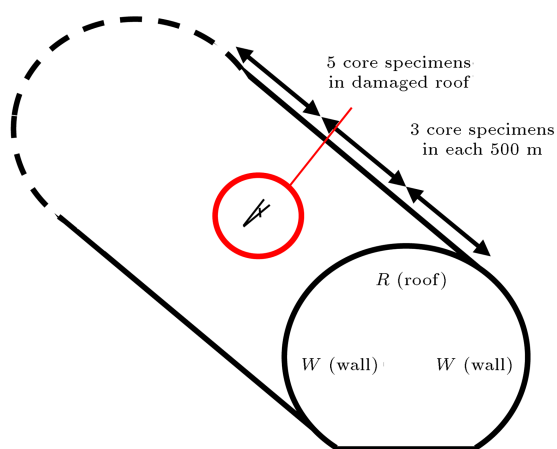
**Figure 1.** Schematic location of the specimens cored in the tunnel.

The tunnel, which is assessed in this paper, is located in the southwest of Iran. During tunnel excavation, concrete segments were severely damaged in some parts. Several damage scenarios were proposed to identify the source of the failure. Due to the high concentration of  $H_2S$  gas and liquefaction of surface layers of concrete segments, sulfate attack (in the forms of TSA and sulfuric acid attack) was suggested. Furthermore, the contractor was required to investigate the likelihood of harmful mechanisms such as ASR. Therefore, 69 core specimens were taken from tunnel segments and a variety of standard tests were performed. The location of the core specimens is schematically shown in Figure 1. As seen in Figure 1, three specimens are cored in every 500 m along the length of the tunnel. Five samples were also extracted from the damaged area of the tunnel roof.

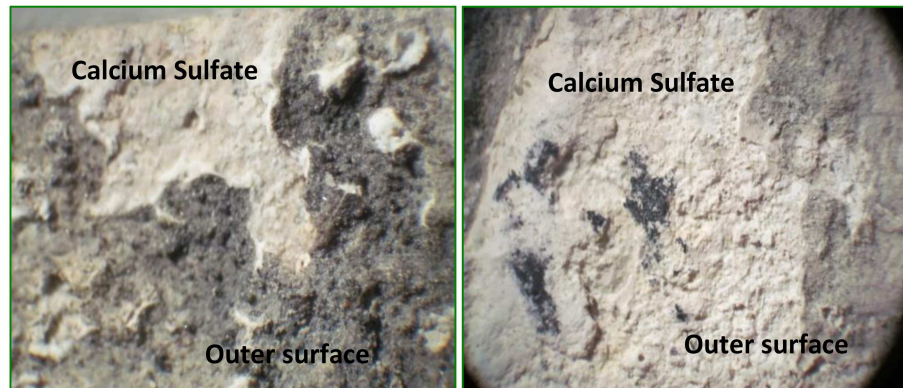
**Figure 2.** Specimen 500R1 transverse sections.

Diffraction (XRD) method, and results are presented in Table 2. As shown in Table 2, the white powder contains calcium sulfate. Stereo microscopic study reveals small holes in the specimen's outer surface, filled up with the same calcium sulfate (Figure 2).

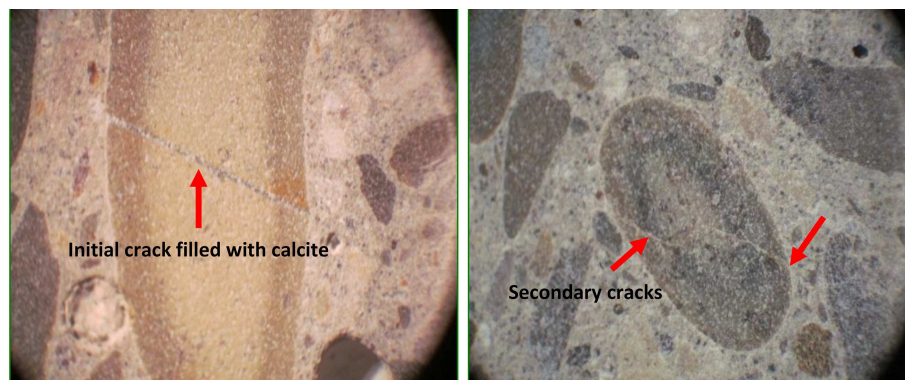
Two types of cracks are observed in the specimen. The first one is found on the surface of aggregates and is filled. These “primary cracks” are inherent in aggregates and are not related to tunnel construction. “Secondary cracks” start from aggregate cores and continue towards the margin of aggregates and voids. Secondary cracks are mainly due to alkali reactions and result in cement weakening (Figure 3).

**Figure 3.** Secondary and primary cracks in specimen 500R1.

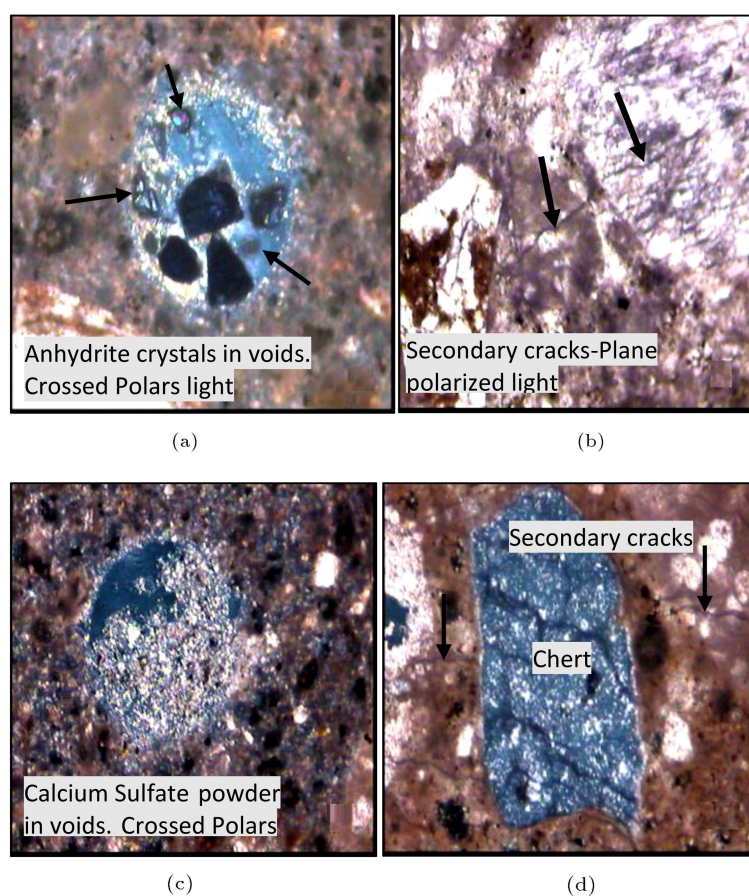
Thin section investigation verifies the presence of calcium sulfate accompanied by anhydrites. In addition, it is shown that chert minerals contain microcrystalline and kryptocrystalline silica, increasing ASR potential (Figure 4).

**Figure 4.** Thin section study of specimen 500R1: (a) Anhydrite, (b) secondary cracks, (c) calcium sulfate, and (d) chert.

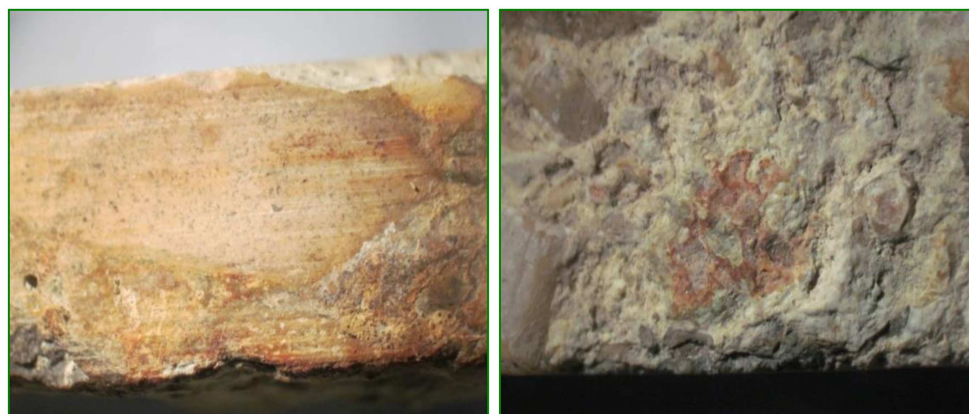
Close observations show ferrous oxide and calcium sulfate in layers that are close to tunnel segments. Stereo microscopic studies show that specimen transverse sections are entirely filled up with calcium sulfate. Aggregation dissolution traces are evident in these sections (Figure 5).

**Figure 5.** Specimen 2500R1 transverse sections.

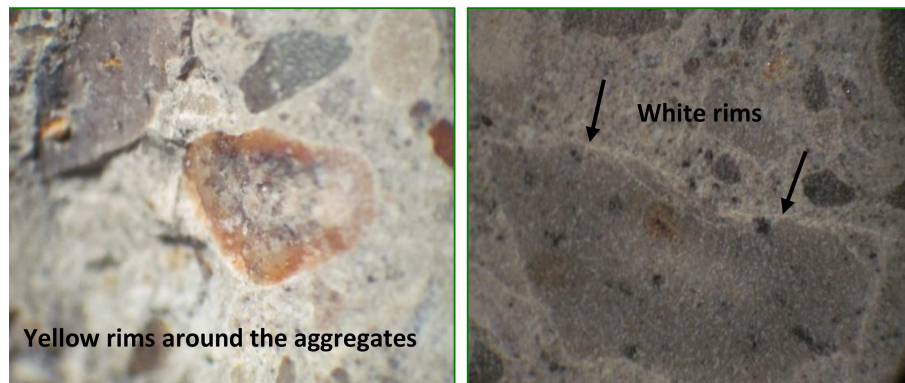
Aggregation composition is similar to specimen 500R. As shown in Figure 6, the same white and yellow rims are clearly seen.

**Figure 6.** Specimen 2500R1 white and yellow rims.

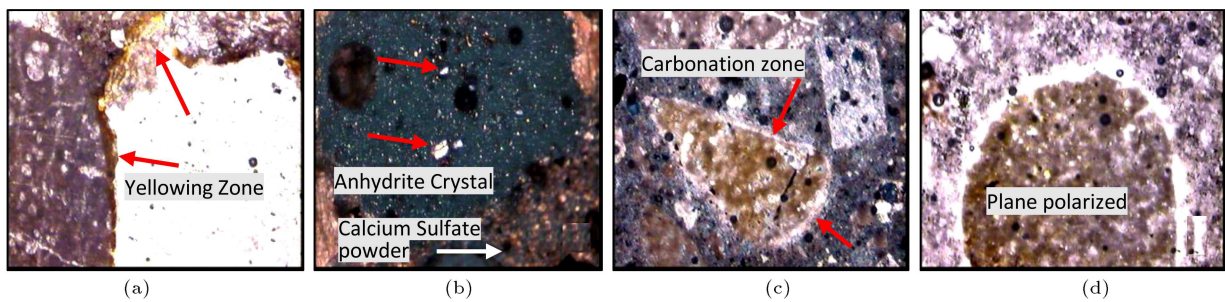
Figure 7 shows a thin section study of specimen 2500R1. It reveals a yellow layer in the boundary of the majority of aggregates. Moreover, it shows voids filled with anhydrate crystals, indicating chemical attack. The adhesion of cement paste and aggregates

is weakened and carbonation is apparent around some of the aggregates.

**Figure 7.** Specimen 2500R1 thin section study: (a) Yellow layer, (b) anhydrite, (c) and (d) carbonation.

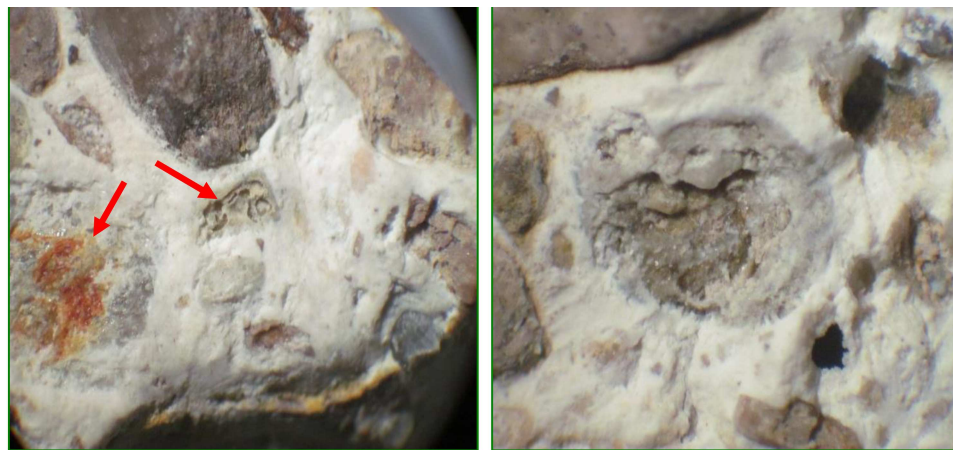
Again, the white powder containing calcium sulfate is observed in outer sections, which were exposed to tunnel environment. Ferrous oxide and corrosion are visible in aggregates. Therefore, the symptoms of a chemical attack are available in this specimen, too (Figure 8).

**Figure 8.** Specimen 11500R1 transverse sections.

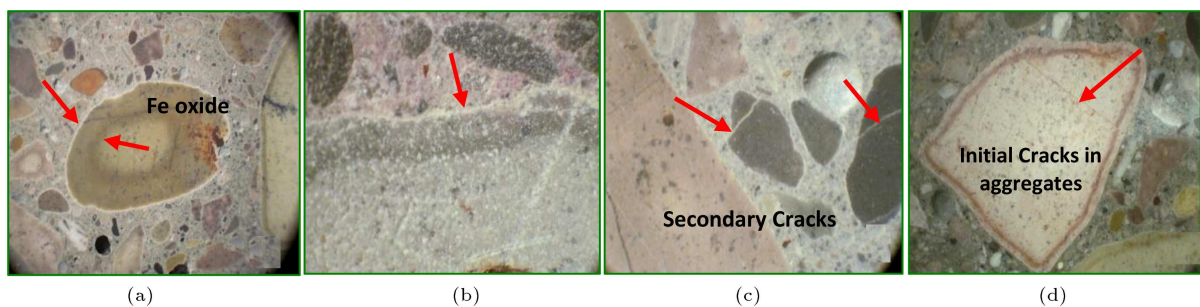
As shown in Figure 9(a) and (b), reaction rims

(dark rims) and white rims (between aggregates and cement paste) are seen. In some cases, ferrous oxide and aggregate segregation are visible. Close to the end of specimens, these signs are less visible.

Figure 9(c) and (d) show secondary and primary cracks that spread in the specimen. Ferrous oxide is observed along some cracks.

**Figure 9.** Specimen 11500R1 longitudinal section: (a) and (b) white and dark rims, (c) secondary, and (d) primary cracks in aggregates.

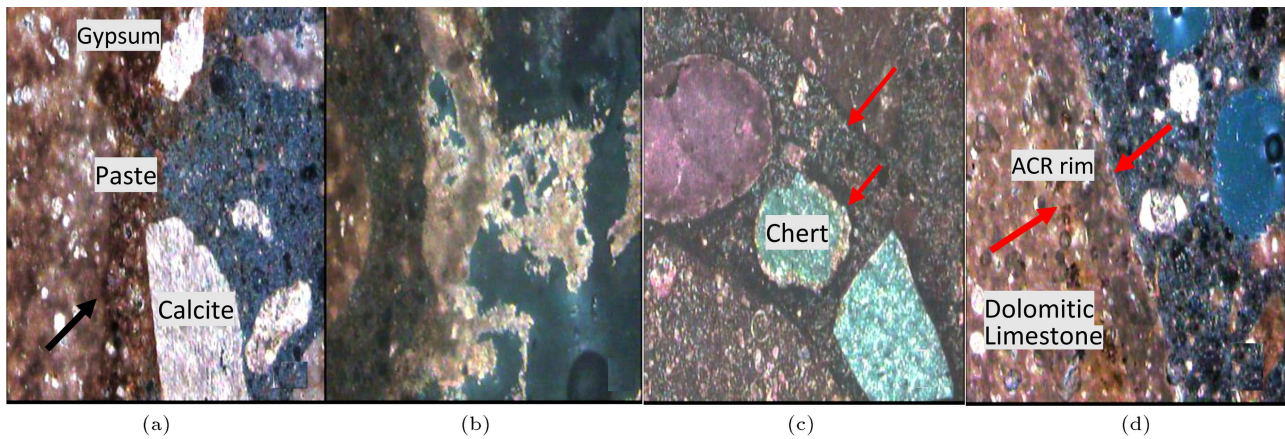
**Figure 10.** Specimen 11500R1 thin section: (a) and (b) outer surface, (c) and (d) inner surface.

of a possible acidic attack. Moreover, carbonation conditions are met in some part of the specimen. Figure 10(a) and (b) show the outer surface. Gypsum mineral and yellowish cement paste around the aggregates are clearly seen. Figure 9(c) and (d) are taken from the inner surface. Figure 9(c) shows the carbonation phenomenon as a dark layer around the aggregates. Figure 9(d) shows reactivity rim as a dark rim around the dolomitic aggregate.

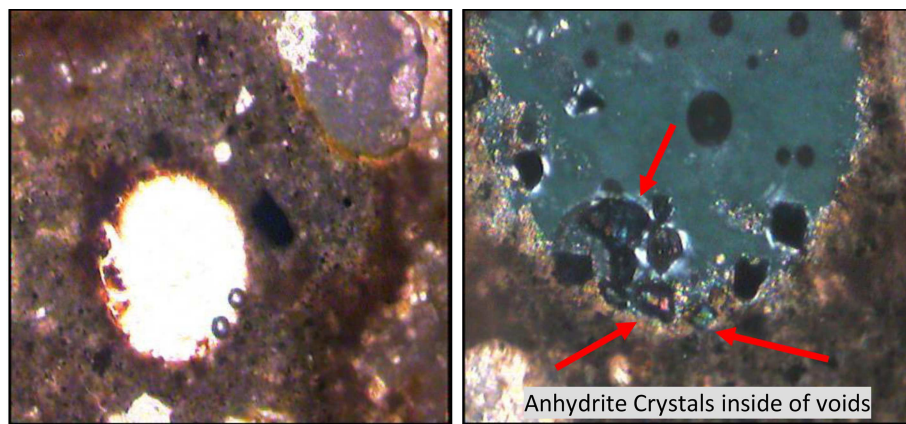
Figure 11 shows the yellowish texture that is seen around voids, aggregates, and cement paste matrix in areas that are attacked by invasive sulfate ions.

**Figure 11.** The yellow texture in specimen 11500R1 thin sections.

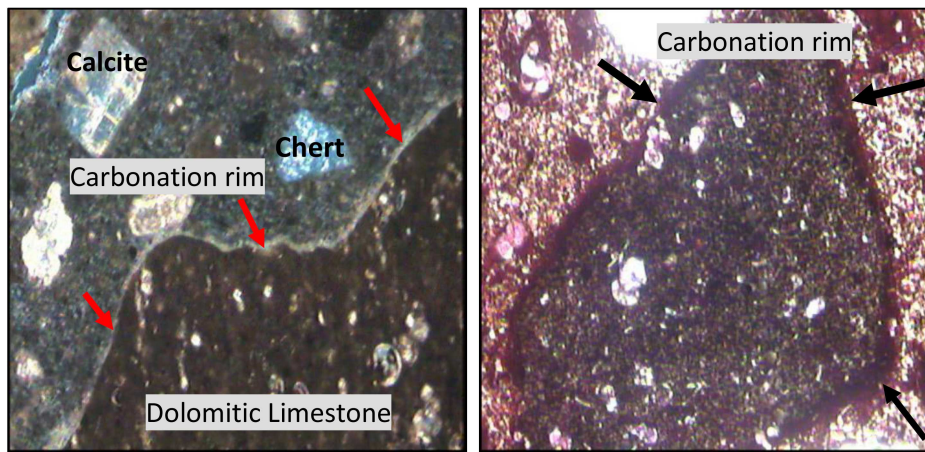
Aggregates consist of dolomitic limestone (40%), siliceous limestone (5%), dolomite (10%), chert (8%), and crystallines. Except for dolomite, the rest of these aggregates have high alkali-silica or carbonation potential. Weak aggregate-cement adhesion and acidic dissolution are observed, too. Calcium Carbonate surrounding some aggregates and, also, carbonation rims are clearly seen in Figure 12.

**Figure 12.** Carbonation rim visible in specimen 11500R1.

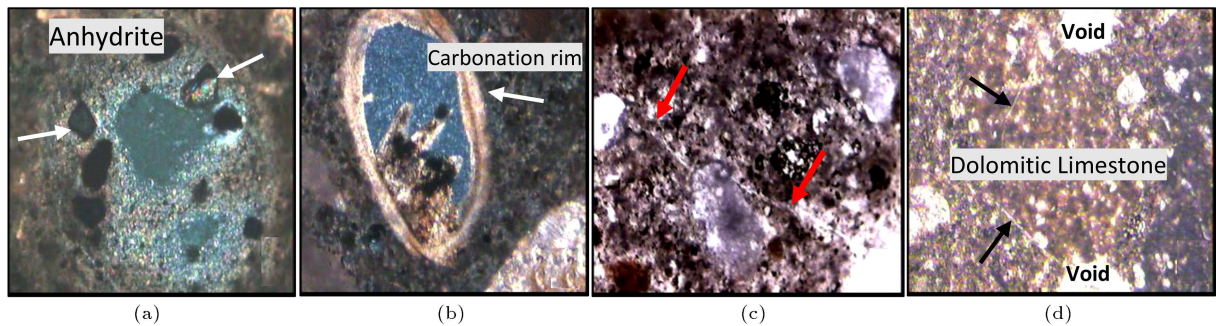
Voids' sizes are about 0.2 mm to 1.5 mm. A large number of voids are spherical. Anhydrite crystals grew in some of the voids that support "sulfate

attack" scenario. Carbonation occurs alongside these voids. Secondary cracks spread in this specimen, too (Figure 13).

**Figure 13.** Specimen 11500R1 voids investigation: (a) Anhydrite, (b) carbonation rim, (c) and (d) primary and secondary cracks.

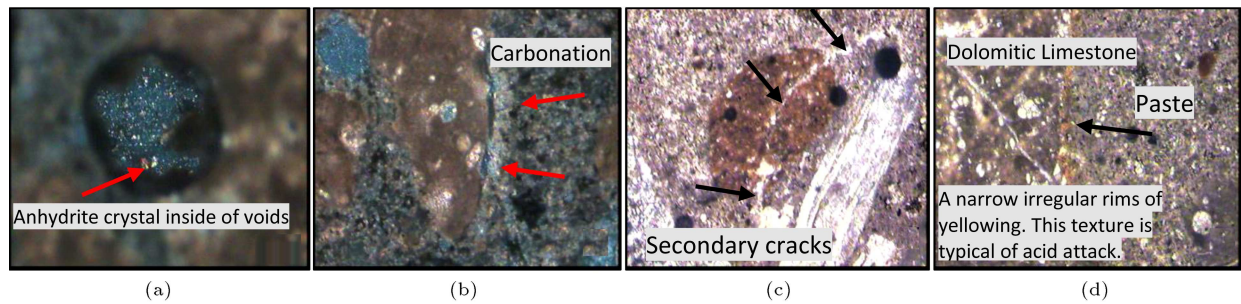
This specimen is not much affected by chemical attack. Slight corrosion and ferrous oxide are visible, but cement paste is strongly connected to aggregates. The aggregate composition is the same. Although secondary cracks are available, they did not grow more than a few millimeters. However, the polarized light microscopic investigation shows the evidence of an acidic attack in the form of yellowish layers and anhydrate minerals inside of the voids. Secondary cracks are available here, too (Figure 14).

**Figure 14.** Specimen 12500L thin section study: (a) Anhydrite presence, (b) carbonation, (c) secondary cracks, and (d) yellowish layer.

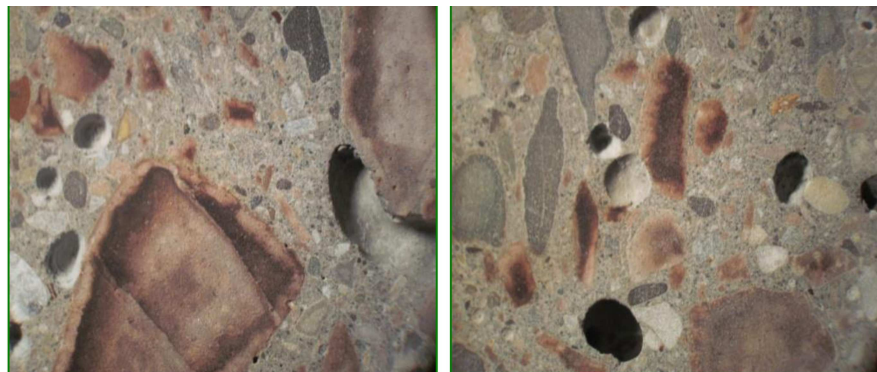
As shown in Figure 15, the burnt-colored aggregate in the first 2.5 cm of the specimen depth is a strong sign of acidic attack. Figure 16 shows white and dark rims and secondary cracks. Voids close to the tunnel segment surface are filled up with calcium sulfate and anhydrite.

**Figure 15.** Burnt aggregates in specimen 14500R longitudinal sections.

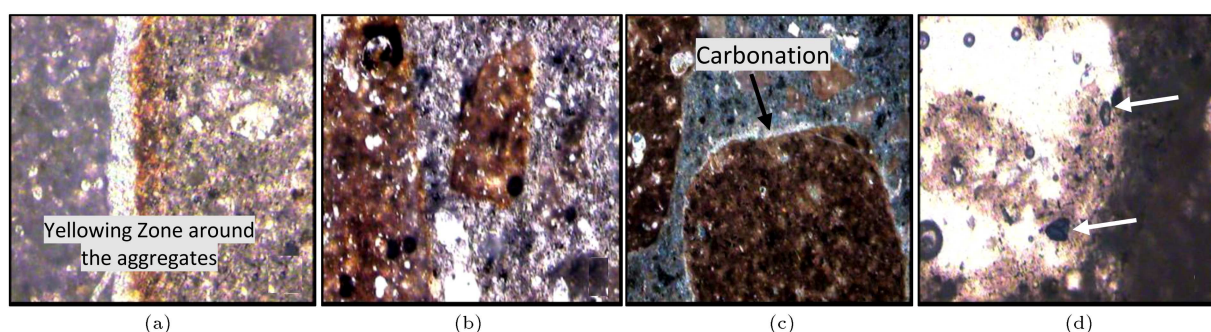
**Figure 16.** Specimen 14500R thin section: (a) Yellowish layer, (b) burnt aggregates, (c) carbonation, and (d) anhydrate and calcium sulfate in voids.
