# Flexural retrofitting of the damaged reinforced concrete beams by using HPFRCC

M.K. Sharbatdar\* and J. Ayyubi

**Abstract.** Damaged structures are not usually reliable to tolerate designed loads and therefore, it is required to retrofit structural parts. The main purpose of this paper is to utilize High-Performance Fibre-Reinforced Cement-based Composite (HPFRCC) as a high-performance material to recover the damaged beams and improve their ductility and moment capacity with experimental approaches. In addition, a retrofitting method was presented using HPFRCC. The experimental study was performed on three simply supported beams with the same dimension, materials, and reinforcement configuration. The first beam, known as the reference beam, is subjected to the pure bending condition until its failure and the others are prone to a certain amount of load according to the final capacity of the first beam. Thereafter, two damaged beams are retrofitted using HPFRCC in the created grooves on the tensile surface of the beam; finally, these retrofitted beams are loaded to determine the bending behavior. Experimental results demonstrate that retrofitting can improve the first crack stre

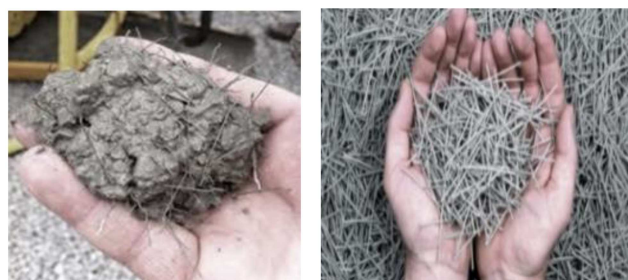
**Figure 1.** Steel fibers, individual, and mixed with concrete.

Accordingly, these steel fibres have been mixed with the concrete with 2% of volume ratio of concrete

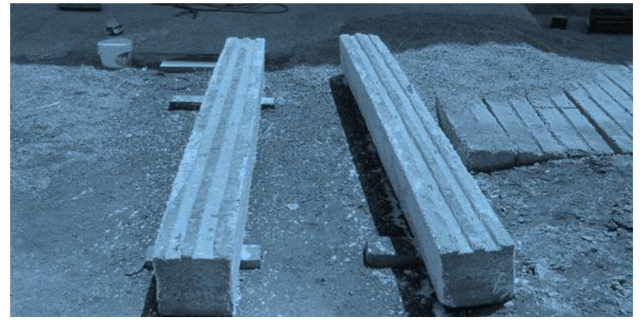
Figure 4. Creation grooves on the tensile surface.

The first beam (reference beam) was subjected to severe load to measure the final crack and two other damaged beams were subjected to 35 and 75% ultimate loads ( $P_u$ ) of the reference beam. In order to ensure the unity and combination treatment of HPFRCC layer and existing concrete in beam and prevent any possible de-bonding of HPFRCC layer from the concrete hard surface, some grooves, as shown in Figure 4, with 30 mm in depth and 40 mm in width were provided using the electrical Grinder machine. Two damaged beams, as shown in Figure 5, were retrofitted, forming a layer of HPFRCC as well as shuttering and concreting

in molds at the bottom parts of the beam in U-shape. It is worth noting that the thickness of HPFRCC layer in all samples is equal to 20 mm (the minimum practical thickness).

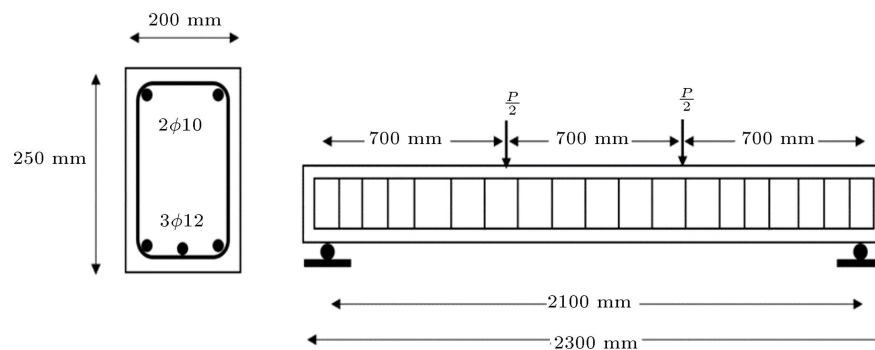
Figure 2. The details of reinforced concrete specimens.

each other placed on the beam symmetrically. Stirrups in beams were provided such that shear cracks would not govern the crack patterns of the beam and all the destruction caused by bending. Dimensions of beam's cross-section were 200 mm width and 250 mm height, as shown in Figure 2, in which all beams had three tensile steel bars with a 12 mm diameter at the bottom and two compressive steel bars with a 10 mm diameter at the top of the beam and 8 mm stirrups placed every 15 cm.

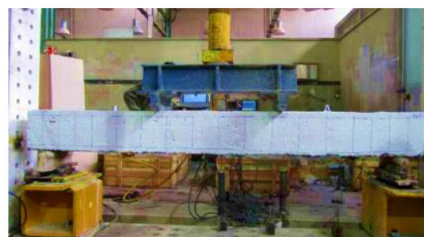
Figure 3. General setup of the three-point bending test of specimens.

Considering that beams are simply supported at a distance of 2100 mm from each other, as demonstrated in Figure 3. Two strain gauges were installed at mid-span on the upper bars and two strain gauges on the lower bars so that the total of four strain gauges could be used to investigate the behavior of these beams.

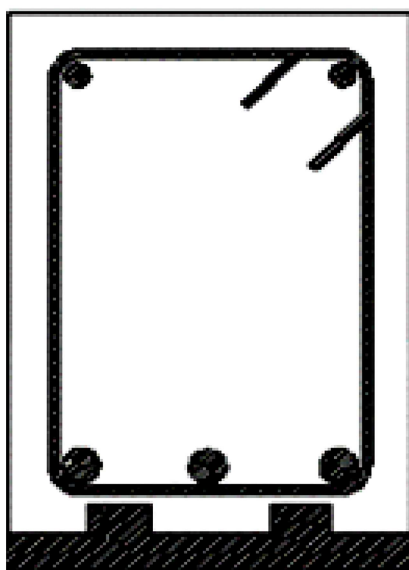
**Figure 5.** Schematic of the High-Performance Fibre-Reinforced Cement-based Composite (HPFRCC) retrofitting layer.

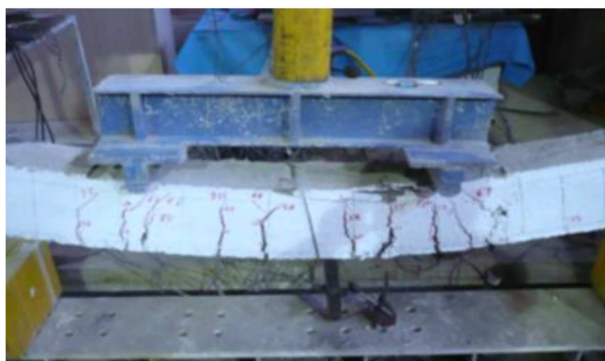
**Figure 6.** Reinforced Concrete (RC) beam failure at the end of test.

bars. Also, the cracks began to appear with tensile cracks at the mid-span and gradually expanded to the supports and thereafter, their width increased. Shear cracks in the vicinity of supports appeared at a 45-degree angle so that the more the applied force increased, the more they expanded and moved to the compression region of beam. By increasing the amount of applied force, the compressive force region in the upper part of the beam was destroyed. Followed by failure, beams' bearing reduction, and displacements in the mid-span, the test was finished. Finally, as shown in Figure 6, the beam was crushed; the RC in accordance with the load-deflection curve in Figure 7 resulted in the force of 88.33 kN and a maximum displacement of 42 mm. In order to have the damaged beams as those shown in Figure 8, after loading the reference sample and reaching the maximum loading equal to 88.33 kN, two other beams were initially

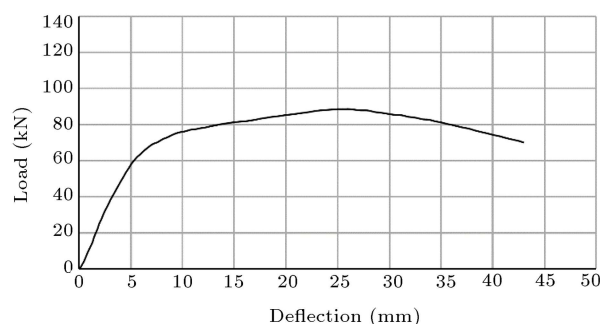
**Figure 7.** Load-deflection curve of the RC beam.

The RC beam with a rectangular cross-section was considered as the reference beam whose reinforcement was quite similar to other samples. This hinged support beam was subjected to the 4-point loading pattern. Before starting the test, the required equipment such as strain gauges, Linear Variable Displacement Transducers (LVDTs), and load-cell was installed on the sample to measure strains on bars, mid-span deflection, and applied loads. The first cracks in the sample occurred due to bending under a force of about 40 kN at mid-span, and tensile reinforcement yielding happened at 65.8 kN from strain gauge reading attached to steel

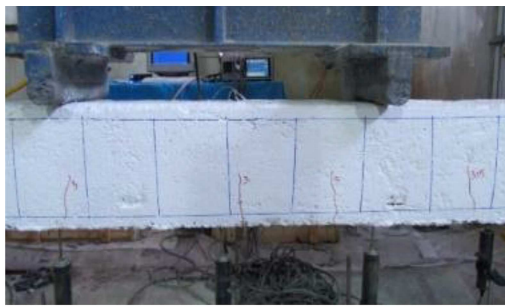
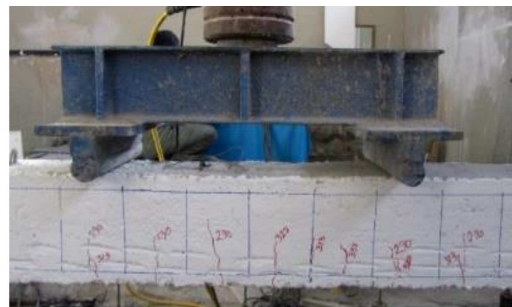
(a) 35% damaged beam

(b) 75% damaged beam

**Figure 8.** Damaged beams before retrofitting.

loaded up to 35 and 75% of final load equal to 30.9 and 66.2 kN, respectively.

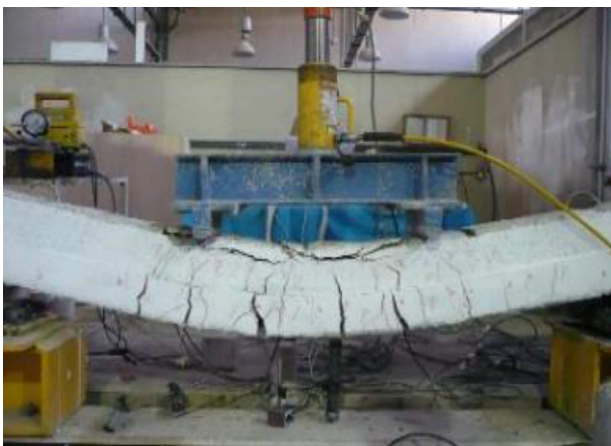
**Figure 9.** Retrofitted beam, B35H, at the end of test.

Then, both damaged beams were retrofitted with HPFRCC of two-centimeter layers and prepared for new loading up to those ultimate capacities. In the damaged beam retrofitted by HPFRCC with 35% load called B35H, besides previous cracks existing in the damaged beam, the first cracks in the retrofitted specimen occurred at the mid-span. Tensile steel bars were yielded in a force of about 95 kN. Cracks began with tensile cracks occurring at the mid-span and gradually became wider. Shear cracks appeared close to the supports at a 45-degree angle; however, these were limited and increase in their width was negligible. Shear cracks were along both tensile and compressive regions and concrete in the compression region between the two concentrated loads was crushed, as depicted in Figure 9. Finally, according to the load-deflection curve in Figure 10, B35H beam had 135.18 kN force and a displacement up to 43.7 mm. Bridging fibers in the tension cracks in the experiment is also of noteworthy observations. No de-bonding occurred between the beam concrete surface and the HPFRCC layer, even at the end of testing, indicating that groove was effective in preventing possible de-bonding.

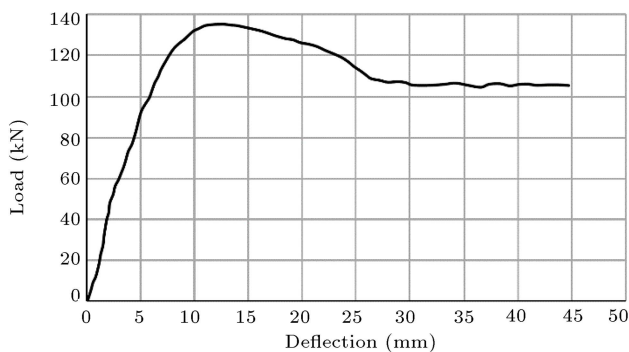
**Figure 10.** Load-deflection curve of the B35H beam.

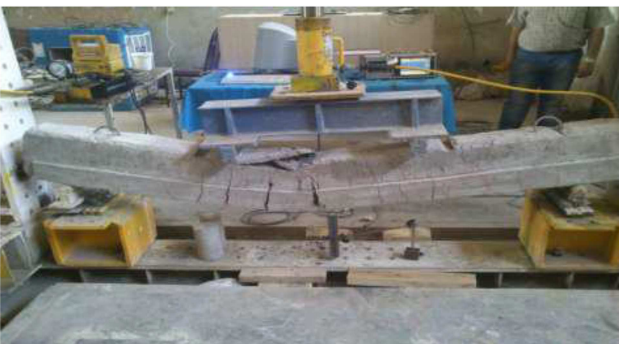
**Figure 11.** Retrofitted beam B75H at the end of test.

In the beam damaged up to 75% and retrofitted with HPFRCC called B75H, in addition to the previous cracks, the first new cracks occurred at the mid-span under the force of about 66 kN. Tensile reinforcement was yielded at 96.5 kN. Cracking with tension cracks at the mid-span gradually expanded and increased in width. Shear cracks occurred near the supports with an angle of 45 degrees; however, these cracks were limited, did not increase in width, spread with increasing force, and expanded into the compression region of beam. In this state, there were more bending cracks and their widths also increased. Shear cracks were across both tensile and compressive regions of concrete and the concrete in the compressive region was crushed between the two centralized forces, as shown in Figure 11. Finally, the B75H beam, according to the load-deflection curve in Figure 12, resulted in a force about 113.1 kN and the maximum displacement of 46 mm. Bridging fibers in the tension cracks is an

interesting observation in this experiment, too. No de-bonding observed between beam concrete surface and HPFRCC layer even at the end of testing B75H specimen such as the B35H specimen, indicating that grooves were effective to prevent possible de-bonding at both strengthened specimens. As shown in Figure 12, the load-displacement curve has the strain hardening of HPFRCC layer after steel bar yielding and prior to reaching the maximum capacity of the beam.

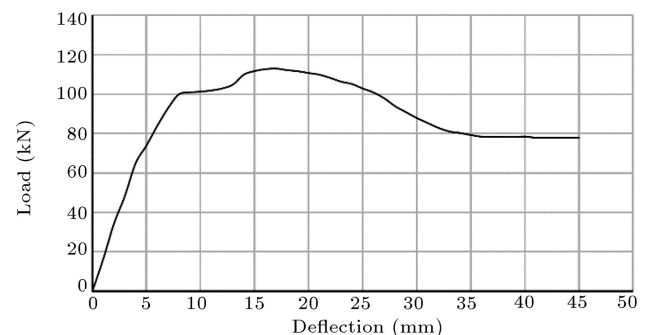
**Figure 12.** Load-deflection curve of the B75H beam.

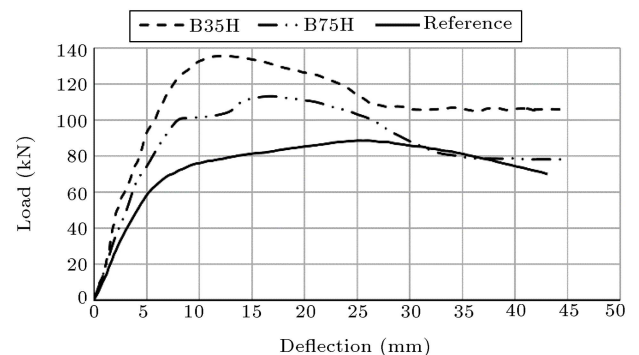
**Figure 13.** Load-deflection curves of the beams Reinforced Concrete (RC), B35H, and B75H.

Values of cracking, yielding, and ultimate loads ( $P_{cr}$ ,  $P_y$ ,  $P_u$ ) as well as the corresponding displacements ( $\Delta_{cr}$ ,  $\Delta_y$ ,  $\Delta_u$ ) of three specimens are given in Table 5, with the load-deflection curves shown in Figure 13.

Energy absorption for each sample is considered as the total area under the load-deflection curve to the failure point of sample or 0.75  $P_u$ , which can indicate the ability of energy dissipation of samples. Table 8 shows the ratio of changes in the energy dissipation caused by the proposed retrofitting. As listed in Table 8, the energy absorption of the retrofitted samples, which are obviously enhanced in comparison to the reference beam, increased.
