Sharif University of Technology
Scientia Iranica
Transactions A: Civil Engineering
<http://scientiairanica.sharif.edu>

Experimental study on performance of repaired and strengthened unreinforced masonry walls using polypropylene bands

S. Ebrahimzadeh and K. Nasrollahzadeh*

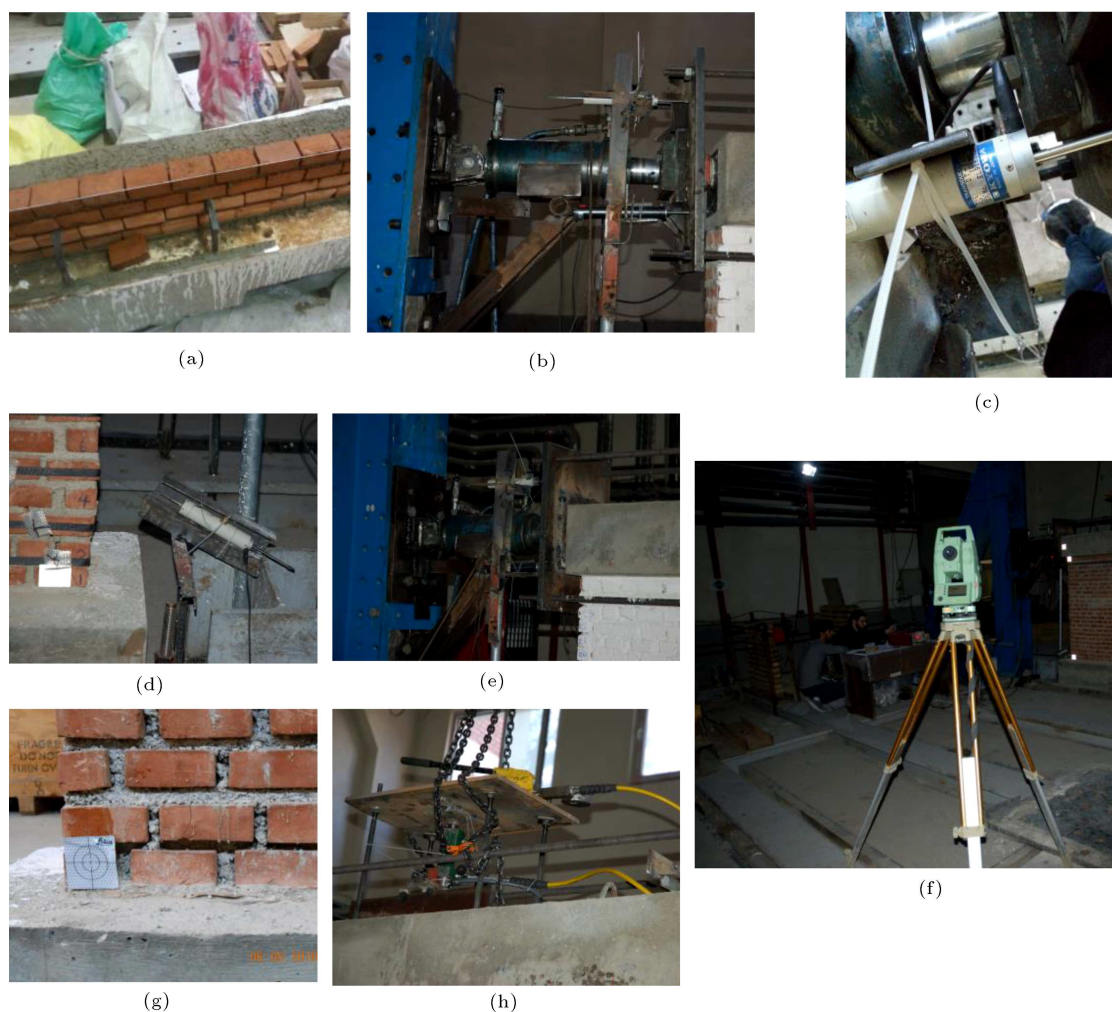
Figure 3. Stages of construction and instrumentation.

According to Figure 3(b) and (c), two loadcells were

placed along the axle shaft of the hydraulic jack and the force distribution beam to measure the value of the applied lateral load. The third loadcell was used to control and measure changes in the vertical load during the experiment (Figure 3(h)). Furthermore, two LVDTs were used horizontally along the applied force to record the horizontal displacement, and the third LVDT was employed along the diameter of the specimen (Figure 3(c)–(e)). It should be mentioned that the upper and lower LVDT distances from the axis of the jackshaft are 21 and 14 cm, respectively. To control the out-of-plane movement of the wall and record the possible rotation period of the force distribution beam, the entire station with the surface accuracy of 1 mm (Figure 3(f)) and targets attached to the bottom, top, and middle of the wall height and, also, connected to the beam was used (Figure 3(g)). The camera operator read the mentioned points at peak moments of displacement and the beginning and end of each loading cycle. The data of the total station camera was utilized to control the movement of the upper concrete beam, which is responsible for

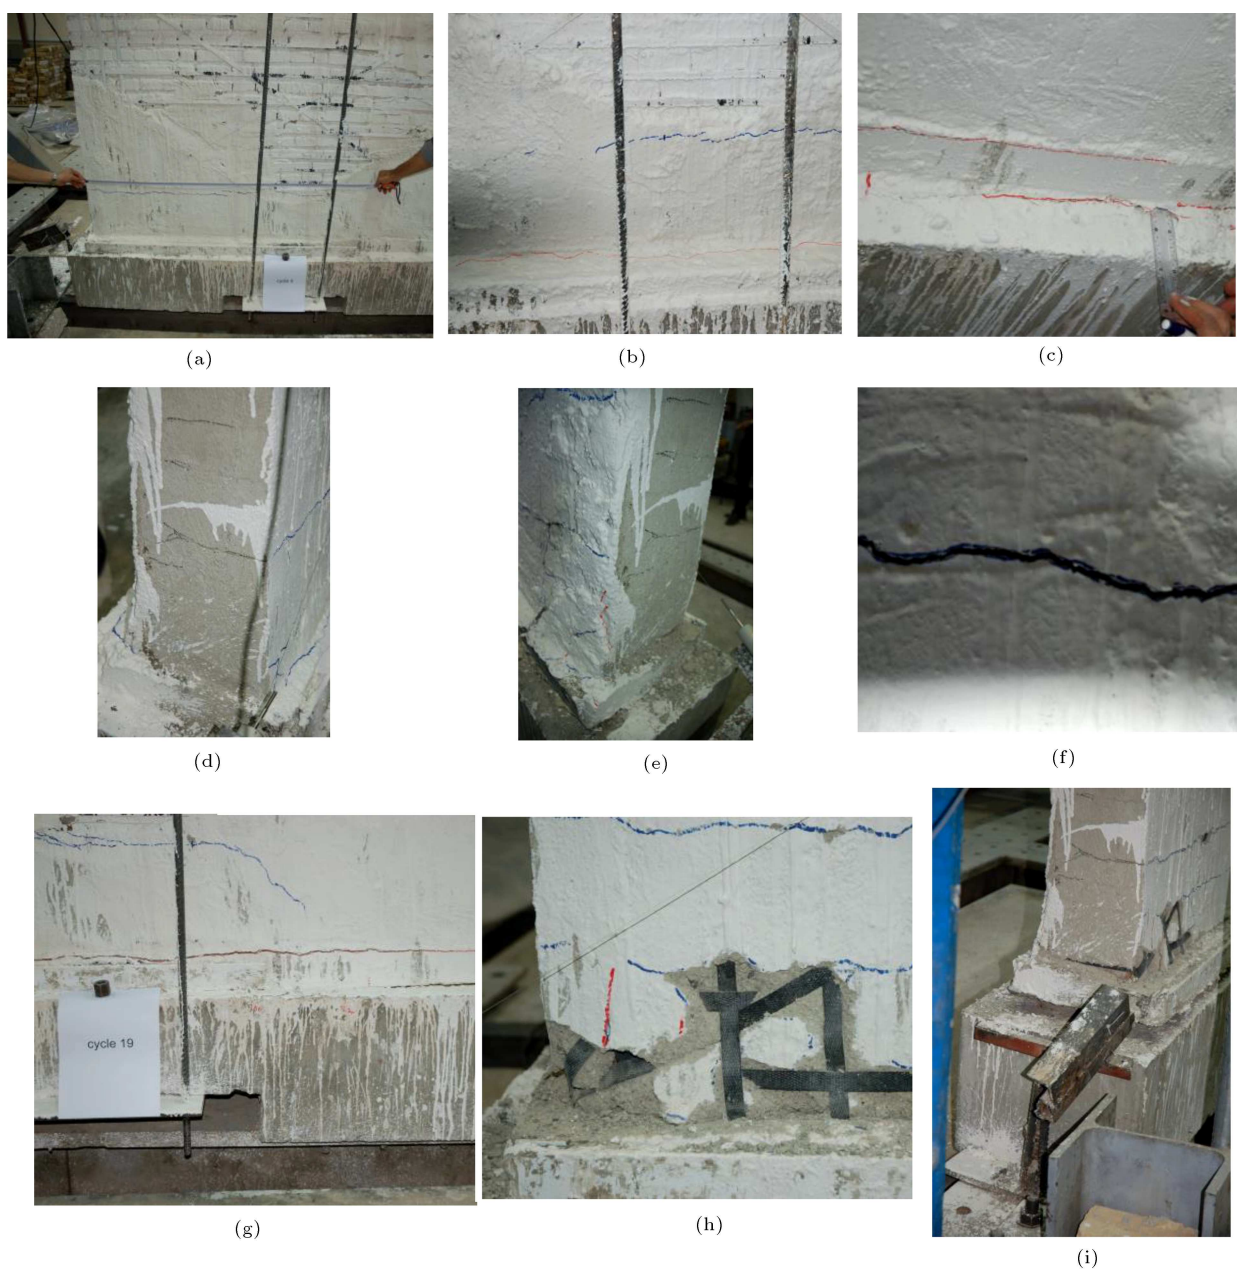
Figure 9. The strengthened masonry wall experiment.

27 cm from the level on the foundation with a length of 72 cm horizontally; and at a 0.15% drift, the crack length increased to 120 cm (Figure 9(a) and (b)). At a displacement of +2.8 mm, a horizontal crack of 120 cm at a height of 27 cm continued diagonally and down the wall with an oblique length of 25 cm to the foundation. At a -2.1 mm displacement of the horizontal crack on the level of the foundation, a horizontal crack with a length of 147 cm was formed. At a 0.14% drift, the crack on the level of the foundation increased to a length of 160 cm. Below the level of the foundation, a horizontal crack of 45 cm length parallel to the top crack was formed on both sides of the wall (Figure 9(c)). At a 0.28% drift in the toe of the wall, a vertical crack with a height of 5 cm appears on both sides of the wall. At a 0.6% drift, diagonal cracks and

cement coat debonding were observed in the toes, and the wall uplifting was recorded as 9 mm from below the foundation (Figure 9(h)), which was observed along the wall and on both sides (Figure 9(g)). No significant change was observed in the crack pattern at a 1% drift at the end of the experiment except for increased debonded areas and toe crushing when the wall experienced a displacement equivalent to 1.6% drift (Figure 9(e)). At a 1% drift, in the toe and a domain with a length of 20 cm and a height of 8 cm, toe crushing occurs. At positive and negative maximum displacements, two rectangle-like areas in both toes with dimensions that are 20 to 25 cm in the length and 15 to 20 cm in the height of the wall are crushed (Figure 9(d)). At the maximum displacement of +19.6 mm, the horizontal crack formed at a level of

26 cm from the foundation was completely closed, and the uplifted length and the width of the crack under the foundation were reported as 120 cm and 26 mm, respectively (Figure 9(f)). At a -9 mm displacement, the wall underwent a horizontal slip of 10 mm in the direction of the force (Figure 9(i)).
