# 1 Visual Corrosion Inspection, Evaluation, and Repair Procedure for Ship 2 Tanks Navigating the Mediterranean Sea

3 Juan José Galán-Díaz\*, Nuria Varela-Fernández

4 Department of Naval and Industrial Engineering, ETSI Caminos, Canales y Puertos, University of  
5 A Coruña, A Coruña, Spain

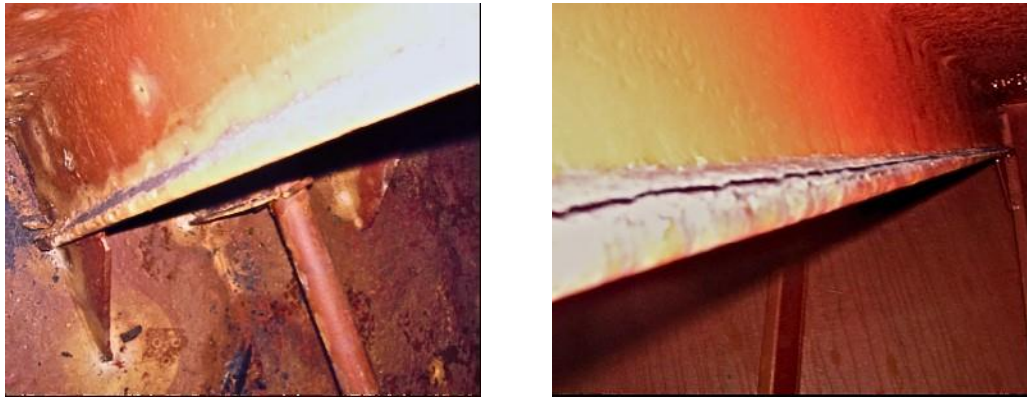
Figure 2a Corrosion damage inside the forepeak. Figure 2b autocatalytic process inside the forepeak

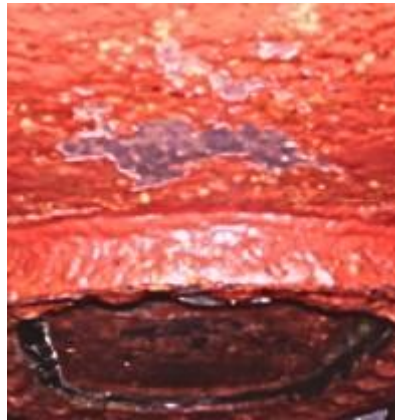
281           Figure 6 illustrates the lack of adherence between the paint and the steel in the area  
282 near the blisters.

Figure 6: Adhesion issue in double bottom central tank 1

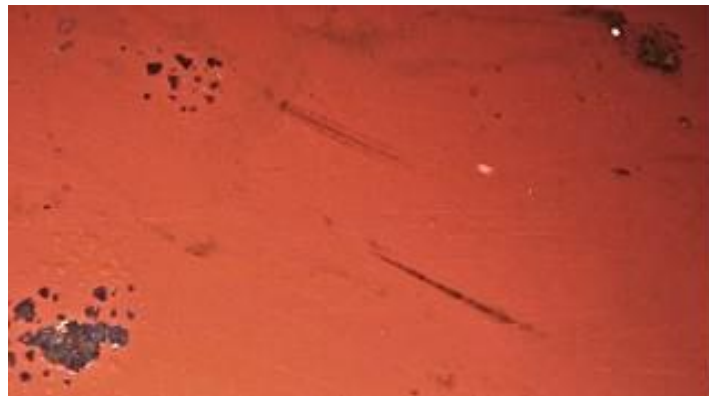
Table 5: Summary of Corrosion Status in Deep Tank 1 SD

Deep Tank 1 SD	Corrosion	Mechanical damage	Rust cracking	Rust peeling	Blisters	Priority
Bulkheads, ceilings and floors	2L	2L		2L	3S	U
