On Fatigue Striations[‡]

Abstract. This paper provides a review of the research that has led to our current understanding of the process of fatigue striation formation. An important question addressed is whether or not at low stress intensity values, fatigue cracks can propagate intermittently in steels and aluminum alloys. It is concluded that there is no valid evidence for propagation on other than a cycle-by-cycle basis.

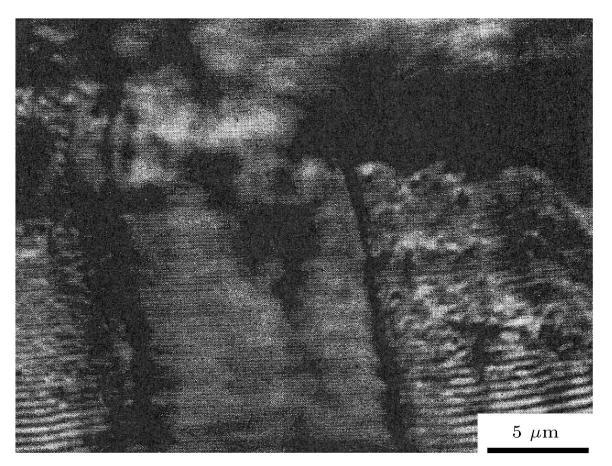
Figure 1. A first micrograph of fatigue striations (7075-T6 aluminum alloy [1] with permission of ASM International®. All rights reserved.)

Interest in fatigue striations began with the seminal 1951 paper "Fractographic Registrations of Fatigue" by Zapffe and Worden [1], which provided the first micrographs of fatigue striations. These fatigue striations were observed by light microscopy in 7075-T6 aluminum alloy, 1010 steel and low-alloy steel, and were immediately recognized to be a characteristic of fatigue crack growth; an example is shown in Figure 1. Since the time of Zapffe and Worden's discovery, research on fatigue striations has been directed at:

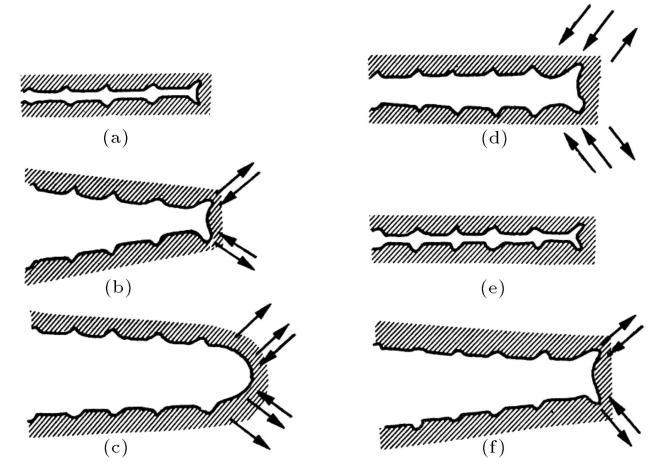
Figure 2. The plastic blunting process of fatigue crack propagation in the stage II mode. (a) Zero load; (b) Small tensile load; (c) Maximum tensile load; (d) Small compressive load; (e) Maximum compressive load; (f) small tensile load. The double arrowheads in (c) and (d) signify the greater width of slip bands at the crack in these stages of the process. The stress axis is vertical ([6] with permission of ASTM).

Research on the mechanism of striation formation following Forsyth and Ryder's work moved ahead rapidly. In 1962, Laird and Smith [5] showed that in a high-strain loading cycle of a ductile metal, crack tip blunting occurred on uploading and a striation accompanied by crack tip re-sharpening occurred on downloading. In this study, the striation spacings were quite large of the order of 100 microns; a 1967 version of this process is shown in Figure 2 [6].

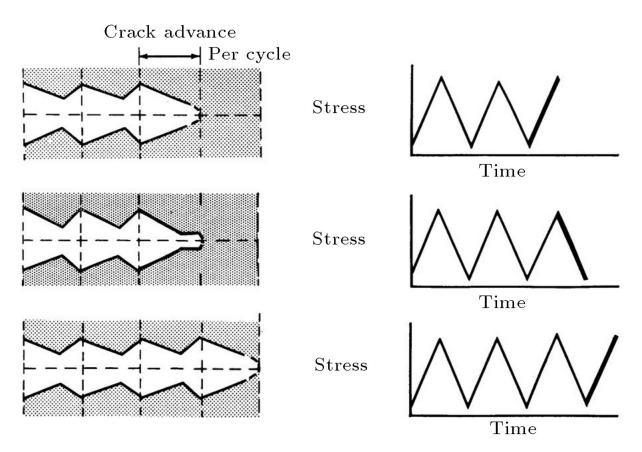
Figure 3. Saw-tooth striations created in the crack propagation sequence ([7] with permission of ASTM).

out an extensive examination of striations formed in aluminum alloy 2024-T3. A two-stage replica technique was used to prepare replicas that were shadowed with germanium in the direction of the crack propagation for examination in an electron microscope. The crack growth rates studied ranged from 2×10^{-7} m/cycle up to 5×10^{-5} m/cycle; much lower than in the work of Laird and Smith [5], and all the fatigue striations were of the ductile type [8]. By examining the contrast resulting from shadowing, McMillan and Pelloux were able to present that the fatigue striations showed a ridge or "saw tooth" profile. They were also able to determine unambiguously the slope orientation on each side of a striation and, with this information, to develop a model for striation formation of the type shown in Figure 3. In the discussion in the paper, Schijve [9] presented a similar model, as shown in Figure 4. The saw-tooth pattern observed by McMillan and Pelloux has since been observed by other investigators, e.g. Mughrabi et al. [10] and Cai and McEvily [11]. The models for striation formation proposed by McMillan

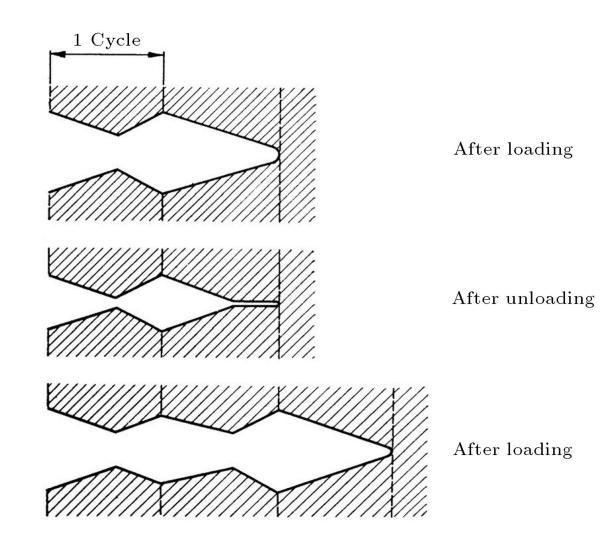
Figure 4. A model for the creation of saw-tooth type striations ([9] with permission of ASTM).

and Pelloux [7] and by Schijve [9] are generally accepted today. However, the matter of whether or not a crack always advances at an increment per cycle at low ΔK levels has remained unsettled.

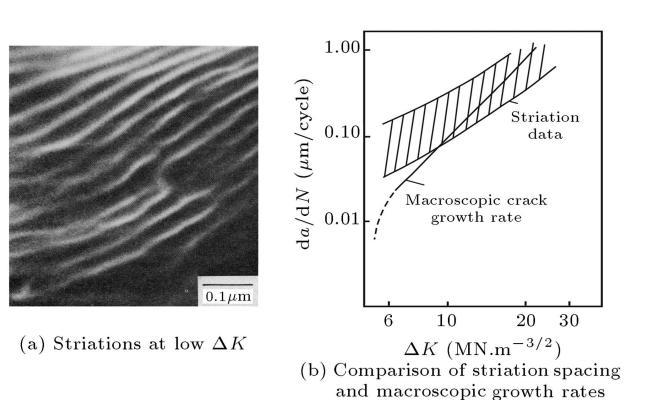
Figure 5. (a) The appearance of striations at low ΔK ; and (b) A comparison of striation spacings and macroscopic growth rates in 7010 high strength aluminum alloy (after [17]).

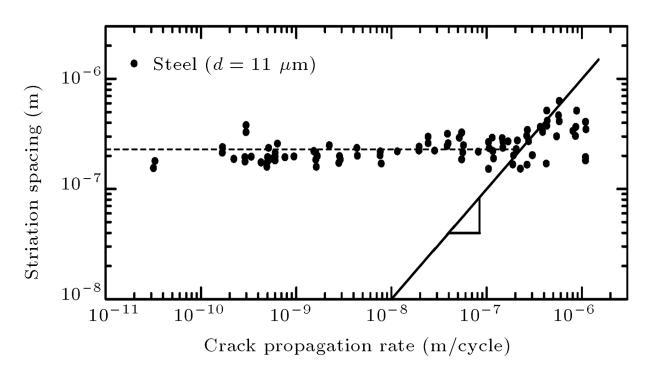
Figure 6. Striation spacing vs. measured crack propagation rate for steel (grain size, $d, \approx 11 \ \mu\text{m}$). Note the constant striation spacings below $da/dN \sim 10^{-7}$ m/cycle. Based upon tests conducted at R = 0.5 in laboratory air (after [19]).

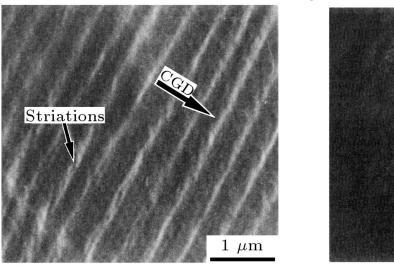
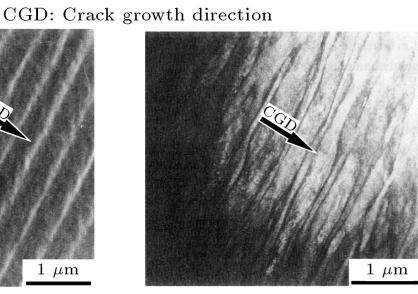
(a) Striations (SEM)

(b) Dislocation arrays beneath the striations shown in (a) (TEM)

Figure 7. Striations and dislocation arrays in 1018 steel ([11] with permission of Elsevier).

Figure 7a shows the appearance of striations formed at a growth rate of 5×10^{-7} m/cycle. Such striations were present over 50-90% of the fracture surface in this range of crack growth rates. Use of the stereo-imaging technique showed that the striations were of the saw-tooth pattern, with the peaks slightly

rounded, and the opposing sides of the fracture surface mirroring each other. Electron diffraction studies of the fracture surface revealed that the average crack growth plane was the $\{110\}$, the resultant of simultaneous slip on two $\{112\}$ in < 111 >. Figure 7b shows the dislocation array beneath the striations shown in Figure 7a, and it can be seen that there is a clear correspondence between striations and dislocation arrays.

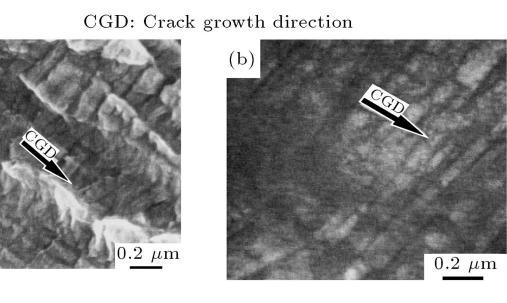
Striations-like markings (SEM)

Dislocation cell structure (TEM)

Figure 8. Striation-like markings in 1018 steel observed at growth rates below 10^{-7} m/cycle and dislocation cell structure underlying striation-like markings (with permission of Elsevier [11]).

The appearance of the fatigue fracture surface which developed at crack growth rates below 1.5×10^{-7} m/cycle is shown in Figure 8a. It is characterized by heavy striation-like markings spaced at an interval of about 1.5×10^{-7} m. The area fraction containing this type of marking increased rapidly below a growth rate of 10^{-7} m/cycle, reaching a level of 90% at a growth rate of 10^{-9} m/cycle. The underlying dislocation array, which was developed in the low growth rate regime, is shown in Figure 8b. It consists of a cell structure, which is elongated in the direction parallel to the crack front, which is usually < 111 > with the angular rotation across a cell boundary being about 5°. It is significant that the width of a cell in the direction of fatigue crack propagation is 1.5×10^{-7} m, exactly the same spacing as that of the striation-like markings observed in this range. Further, whereas the saw-tooth striation markings were difficult to detect below a growth rate

of 2×10^{-7} m/cycle, the striation-like markings were clearly evident.

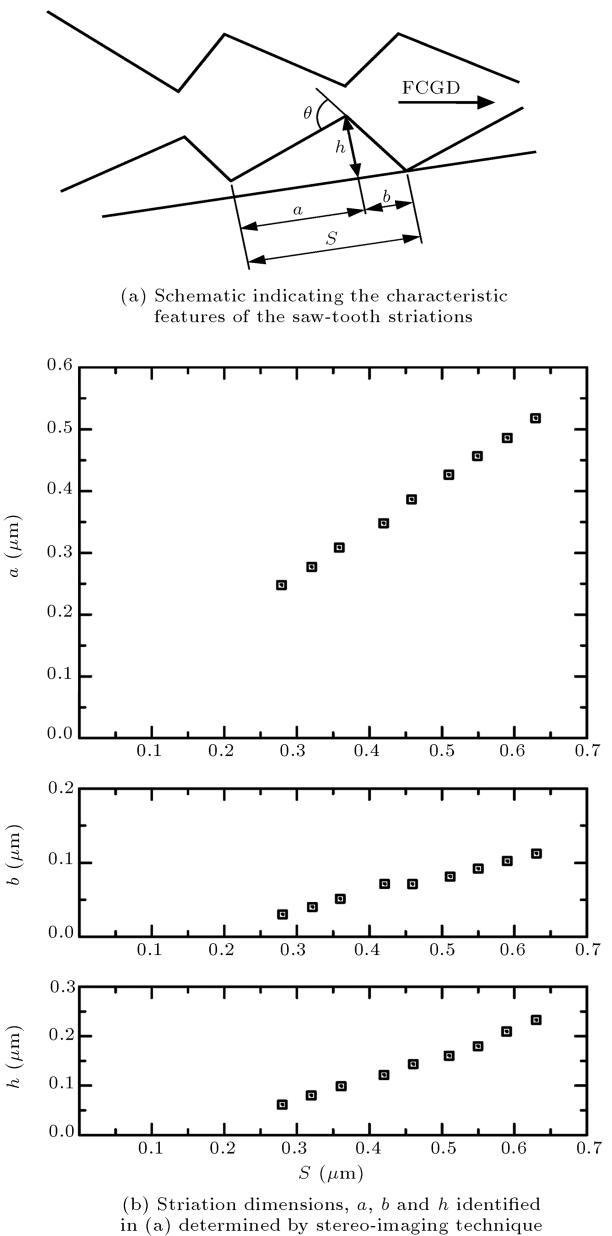
FCGD: Fatigue crack growth direction

Figure 9. Characteristics of saw-tooth striations in 1018 steel [20].

Figure 9a is a schematic diagram, which indicates the characteristic features of the saw-tooth striations found in 1018 steel. The striation dimensions, a, b and h, identified in Figure 9a and determined by stereo-imaging techniques are shown in Figure 9b. Of particular interest is the fact that, in accordance with our observations of striations, the striation height for 1018 steel goes to zero at a fatigue crack growth rate of the order 10^{-7} m.

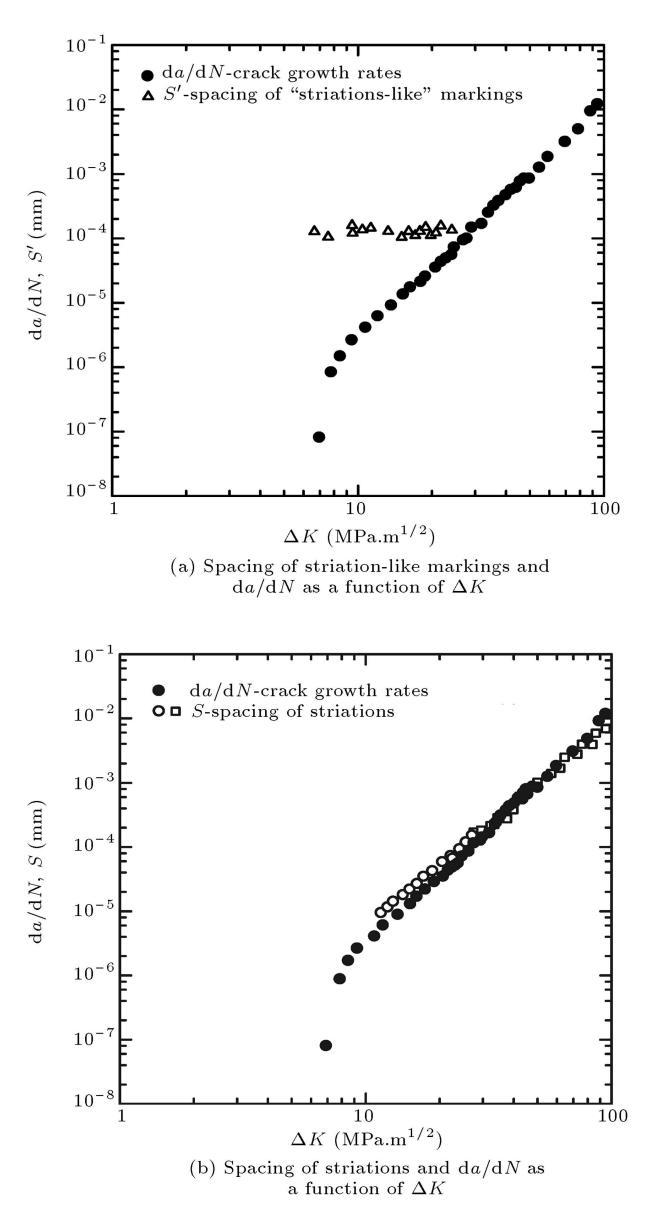
Figure 10. Comparison of fatigue crack growth rates with fracture surface markings in 1018 steel [20].

A plot of da/dN as well as the spacing between striation-like markings obtained by Cai [20], as

a function of ΔK , is shown in Figure 10a. Note that the spacings of these well-defined striation-like markings are just about 10^{-7} m/cycle (at the growth rate corresponding to the limit of resolution of the striations). The spacings of the striation-like markings for 1018 steel are similar to those of the spacings shown in Figure 6 for microalloyed steel [19]. Careful examination of the region between the striation-like markings revealed additional markings that were parallel to the crack front at crack growth rates in the interval between 10^{-8} to 10^{-7} m/cycle. The spacings of these markings corresponded closely to the average crack growth rate, as shown in Figure 10b. We, therefore, conclude that the markings observed by Roven and Nes [19] were fissures in cell boundaries, not striations.

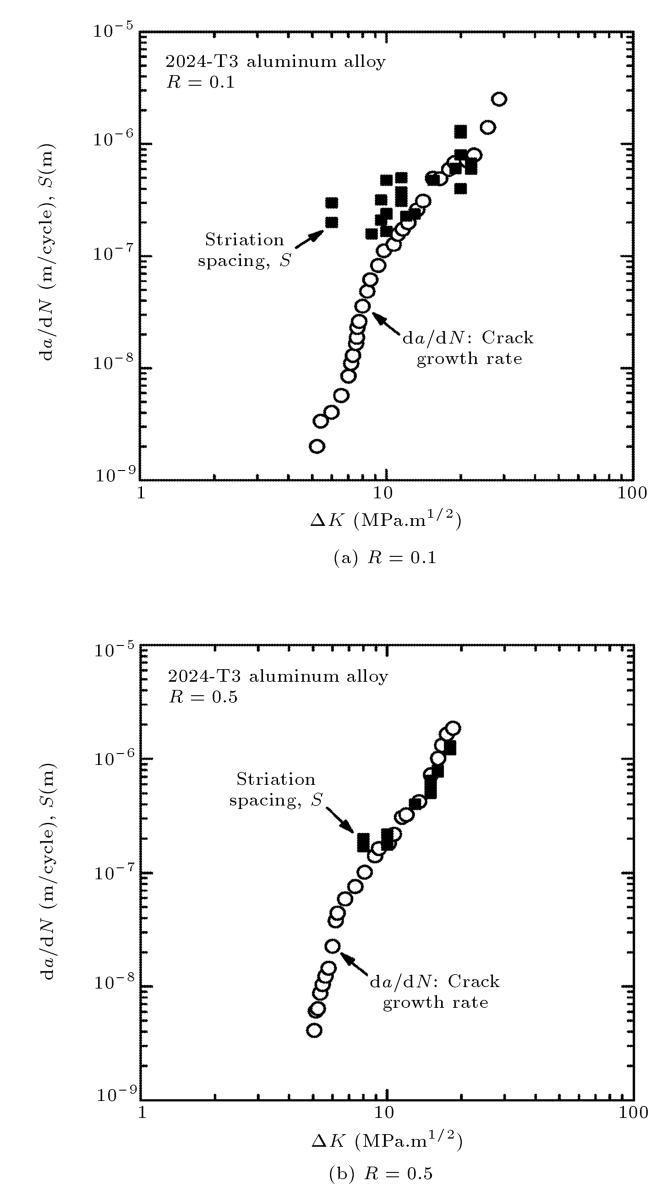
Figure 11. Comparison of striation spacings and macroscopic growth rates in 2024-T3 aluminum alloy.

Fatigue crack growth tests were carried out on compact specimens of aluminum alloys 2024-T3 and 2519-T87. Figure 11a shows the results for 2024-T3 tested at R = 0.1. As observed by Nix and Flower [17] and others, at the lower ΔK values, the striation spacings exceed the corresponding da/dN values. However, at R = 0.5, there is better agreement between striation spacings and da/dN values, as a function of ΔK (Figure 11b).

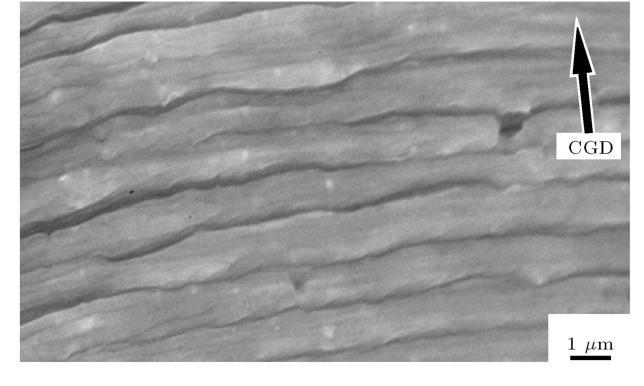
Figure 12. Striations in 2024-T3 aluminum alloy $(\Delta K = 20 \text{ MPa.m}^{1/2}, R = 0.1, \text{ CGD: Crack growth direction}).$

Figure 12 shows the appearance of the fatigue fracture surface in 2024-T3 at a ΔK value of 20 MPa.m^{1/2} for R = 0.1 in an area where the striations are well defined. However, the fraction of area in

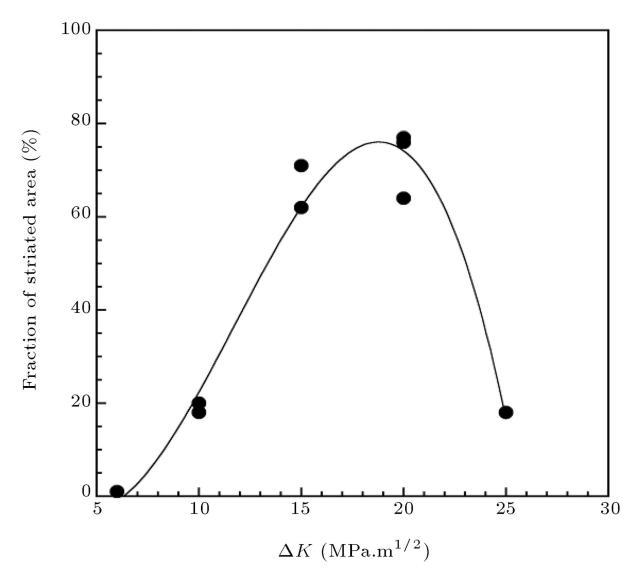
Figure 13. Fraction of striated area as a function of ΔK in 2024-T3 aluminum alloy tested at R = 0.1.

which such striations are found varies with the ΔK level as shown in Figure 13. It is important to note that less than 1% of the fracture surface contains striations at a ΔK of 6 MPa.m^{1/2}; a level at which the striation spacing exceeds the corresponding da/dNvalue for 2024-T3. Similar results have been obtained by Otsuka et al. [21] for annealed low carbon steels and by Yamagiwa et al. [22] for 2.25Cr-1Mo steel.

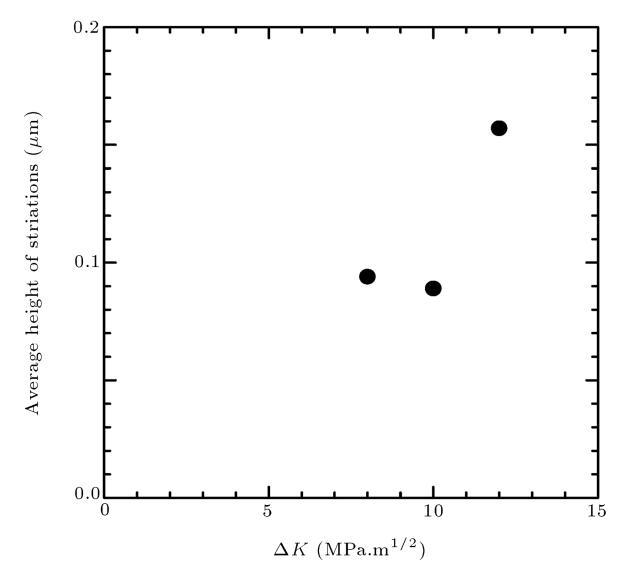
Figure 14. Height of striations as a function of ΔK in 2024-T3 aluminum alloy tested at R = 0.1.

Figure 14 is a plot of the height of the striations for values of 8, 10 and 12 MPa.m^{1/2}. In contrast to steel, it is not possible to extrapolate to zero height in Figure 14 because of the anomalously high striation spacings at low ΔK . However, the lower limit of resolution in aluminum alloy occurs at a growth rate of $3 \sim 4 \times 10^{-8}$ m/cycle based upon the observations of Hertzberg and Paris [12] and Broek and van der Vet [13]. In the present study, it has been found that the corresponding growth rate in steel is higher;

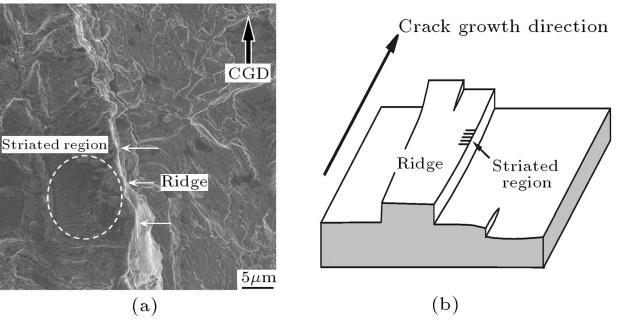
Figure 15. Striated region at $\Delta K = 6$ MPa.m^{1/2} in 2024-T3 aluminum alloy tested at R = 0.1.

The cause of the discrepancy between da/dNvalues and striation spacings differs in comparing steel with aluminum alloy. In the case of steel, striationlike markings were created at cell boundaries. In aluminum, cells did not form. It is significant that in aluminum alloy at a ΔK of 6 MPa.m^{1/2}, only one percent, perhaps even less, of the fracture surface contains striations. We note that at a ΔK of 6 MPa.m^{1/2}, in a small region where striations were observed, a ridge ran in the direction of crack propagation, as shown in Figure 15. We propose that this ridge is a barrier to crack propagation and that, at this location, the crack front was temporarily arrested. As the rest of the crack front moved on, the crack opening displacement at the crack arresting point gradually increased until the resistance at the arresting point was overcome. Then, the lagging portion of the crack front moved forward rapidly to join up with the rest of the crack front, giving

rise to striations more widely spaced than the average growth rate. Except at the arrest points, the process of fatigue crack growth was cycle-by-cycle in nature. It is noted that at R = 0.5, little, if any, discrepancy exists between the striation spacings and the da/dN values. This may mean that the impediments to crack growth are less effective at high mean stress than at low mean stress.

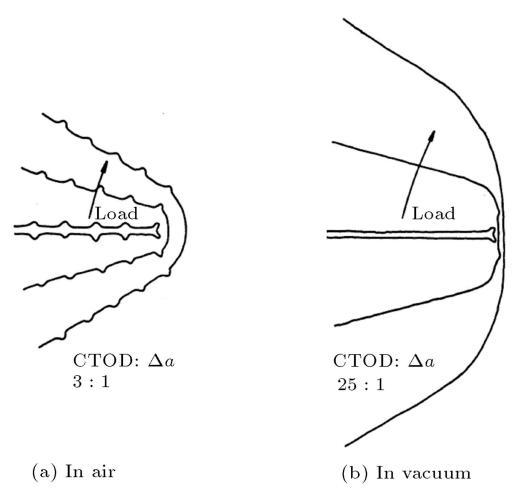
Figure 16. A schematic representation indicating the influence of the environment on striation formation ([23] with permission of TMS).

It has long been known that if a fatigue crack is grown in a vacuum environment, striations are difficult to observe. For example, for both 1018 steel and 2519-T87 tested in vacuum, striations were not observed. McEvily and Gonzalez [23] observed that the crack tip opening displacement for 304 stainless steel was much larger in vacuum than in air, and proposed that the reason for the absence of striations in vacuum was that, although a striation was created at the crack tip on unloading, it was swept into the crack flanks during the next loading cycle as indicated in Figure 16, and so disappeared.

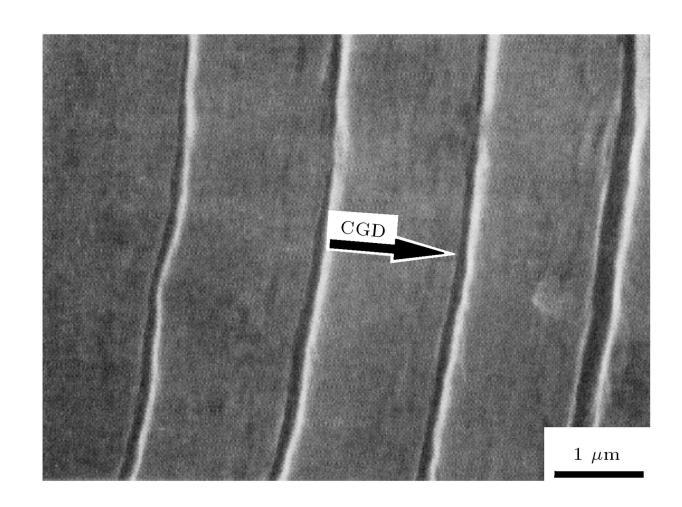
Figure 17. Type B striations in 2519-T87 aluminum alloy [20].

Nix and Flower [17] have noted that two types of striation can form in aluminum alloy 7010-T76 tested in an ambient environment. One is basically a sawtooth type (Type A [8]), and the other consists of deep slots traversing an essentially flat (110) fracture surface (Type B). Type B striations also developed in 2519-T87 and differed considerably in appearance from the Type A striations formed in 2024-T3, as can be seen by comparing Figures 12 and 17. In 2519-T87 [20], the striations resemble more the striations of Laird and Smith [5] (Figure 2), and the Type B striations observed by Nix and Flower for aluminum alloy 7010-T76.
